**An Evaluation of the Existing Trees
Classic Communities Development Project
36120 Ruschin Drive
Newark, California**

January 28, 2014

Job #01-14-2006

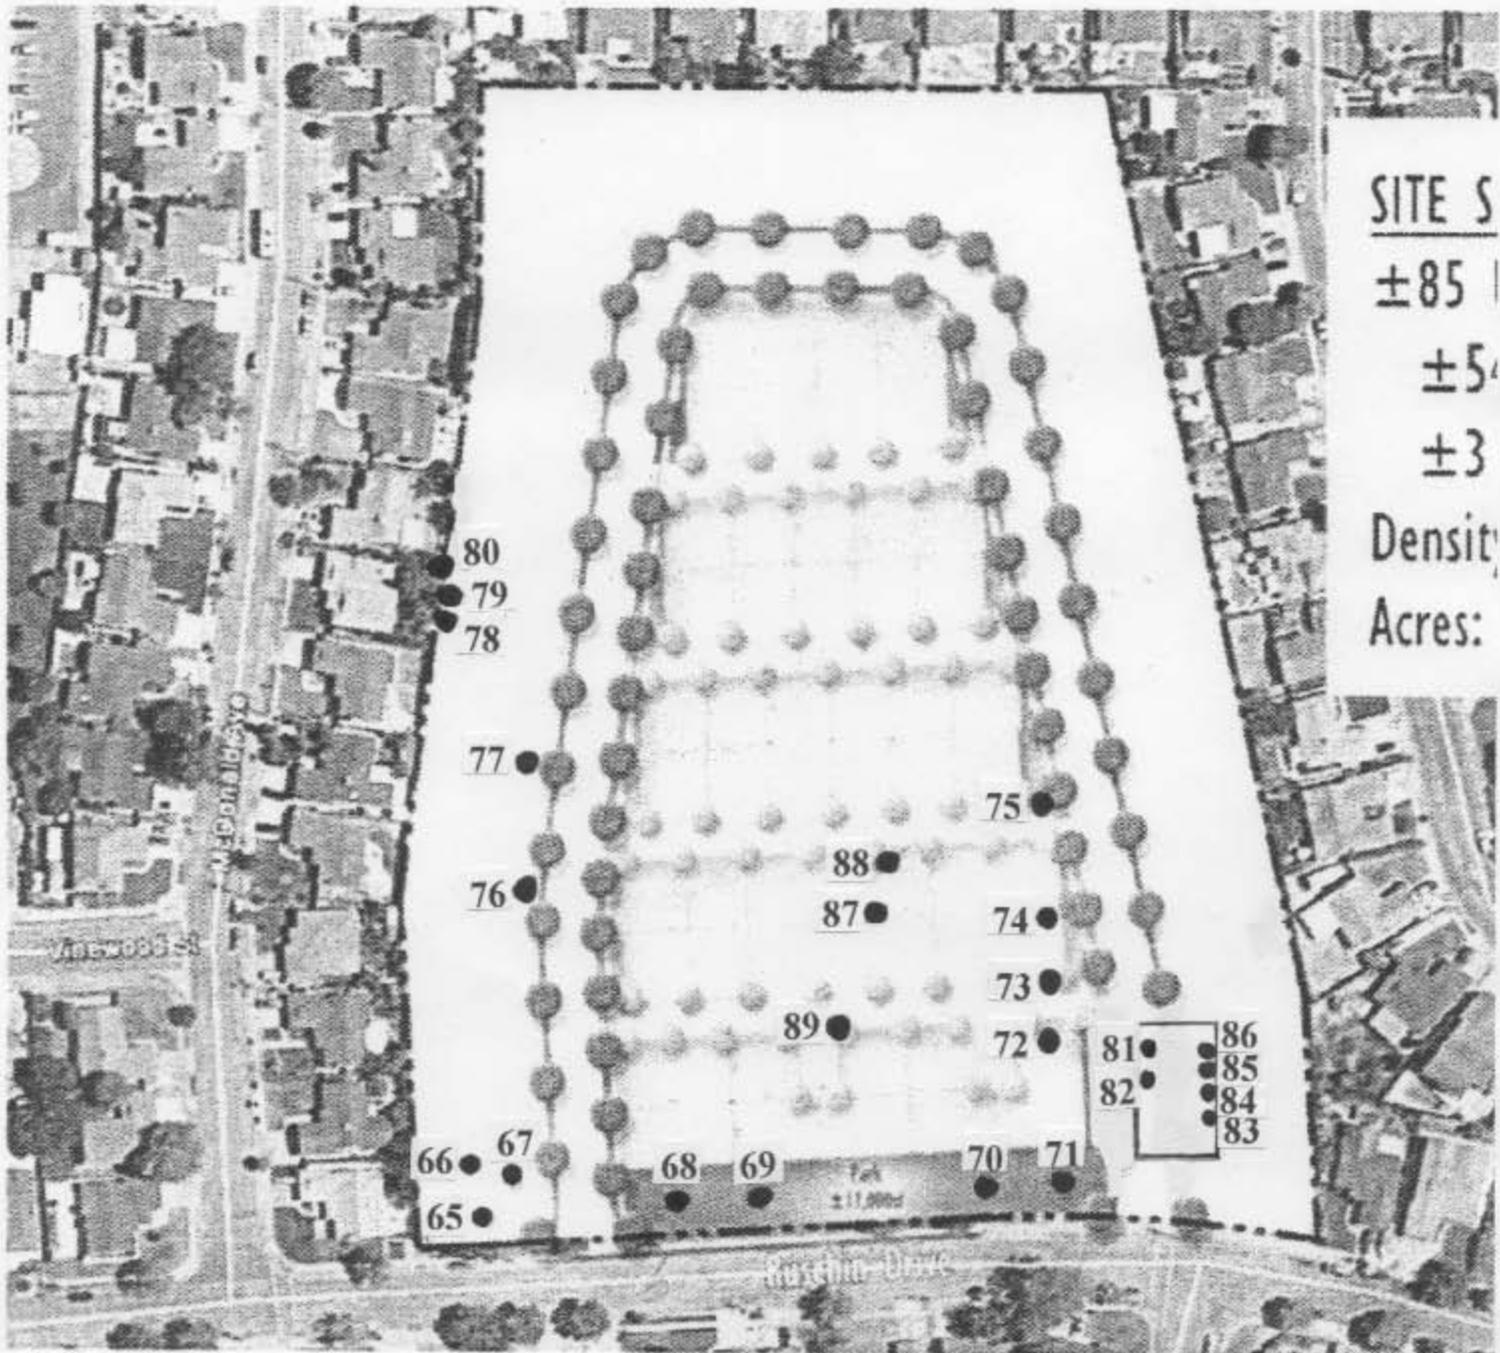
Tree Map
A Mark-Up of the Conceptual Survey Plan
Tree Locations Estimated
Site: Classic Communities Development
36120 Ruschin Drive
Newark, California
1-28-14
Prepared by Michael L. Bench,
Consulting Arborist
Barrie D. Coate and Associates

The map provided for this evaluation is a Conceptual Site Plan prepared by Bassenian Lagoni Architecture. I have marked the approximate locations of the existing trees on this map, which is included in the attachments.

There are 24 trees on this property and 1 tree (Tree #80) located on an adjacent property, all of which may be impacted by proposed construction.

Trees #81-86 are located inside a locked chain-link fence enclosure, and Trees #87, 88, and 89 are located inside a courtyard between classroom buildings. I could not enter those areas and for that reason, I estimated the trunk measurements of those trees at a distance.

The neighboring Tree # 80 is a cypress. It is in good health. Its canopy extends onto this site by a few feet. Its root system no doubt also extends onto this site. To preserve this tree, it will be essential that no excavation or trenching be done within 8 feet of the trunk.
