ASTM PHASE I AND PHASE II  
ENVIRONMENTAL SITE ASSESSMENTS

**REPORT ON  
ASTM PHASE I ENVIRONMENTAL SITE ASSESSMENT  
CARGILL PROPERTY - 54.53-ACRE PARCEL  
SOUTHWEST OF HICKORY STREET AND  
ENTERPRISE DRIVE  
NEWARK, CALIFORNIA**

**File No. 40451-000  
January 2014**

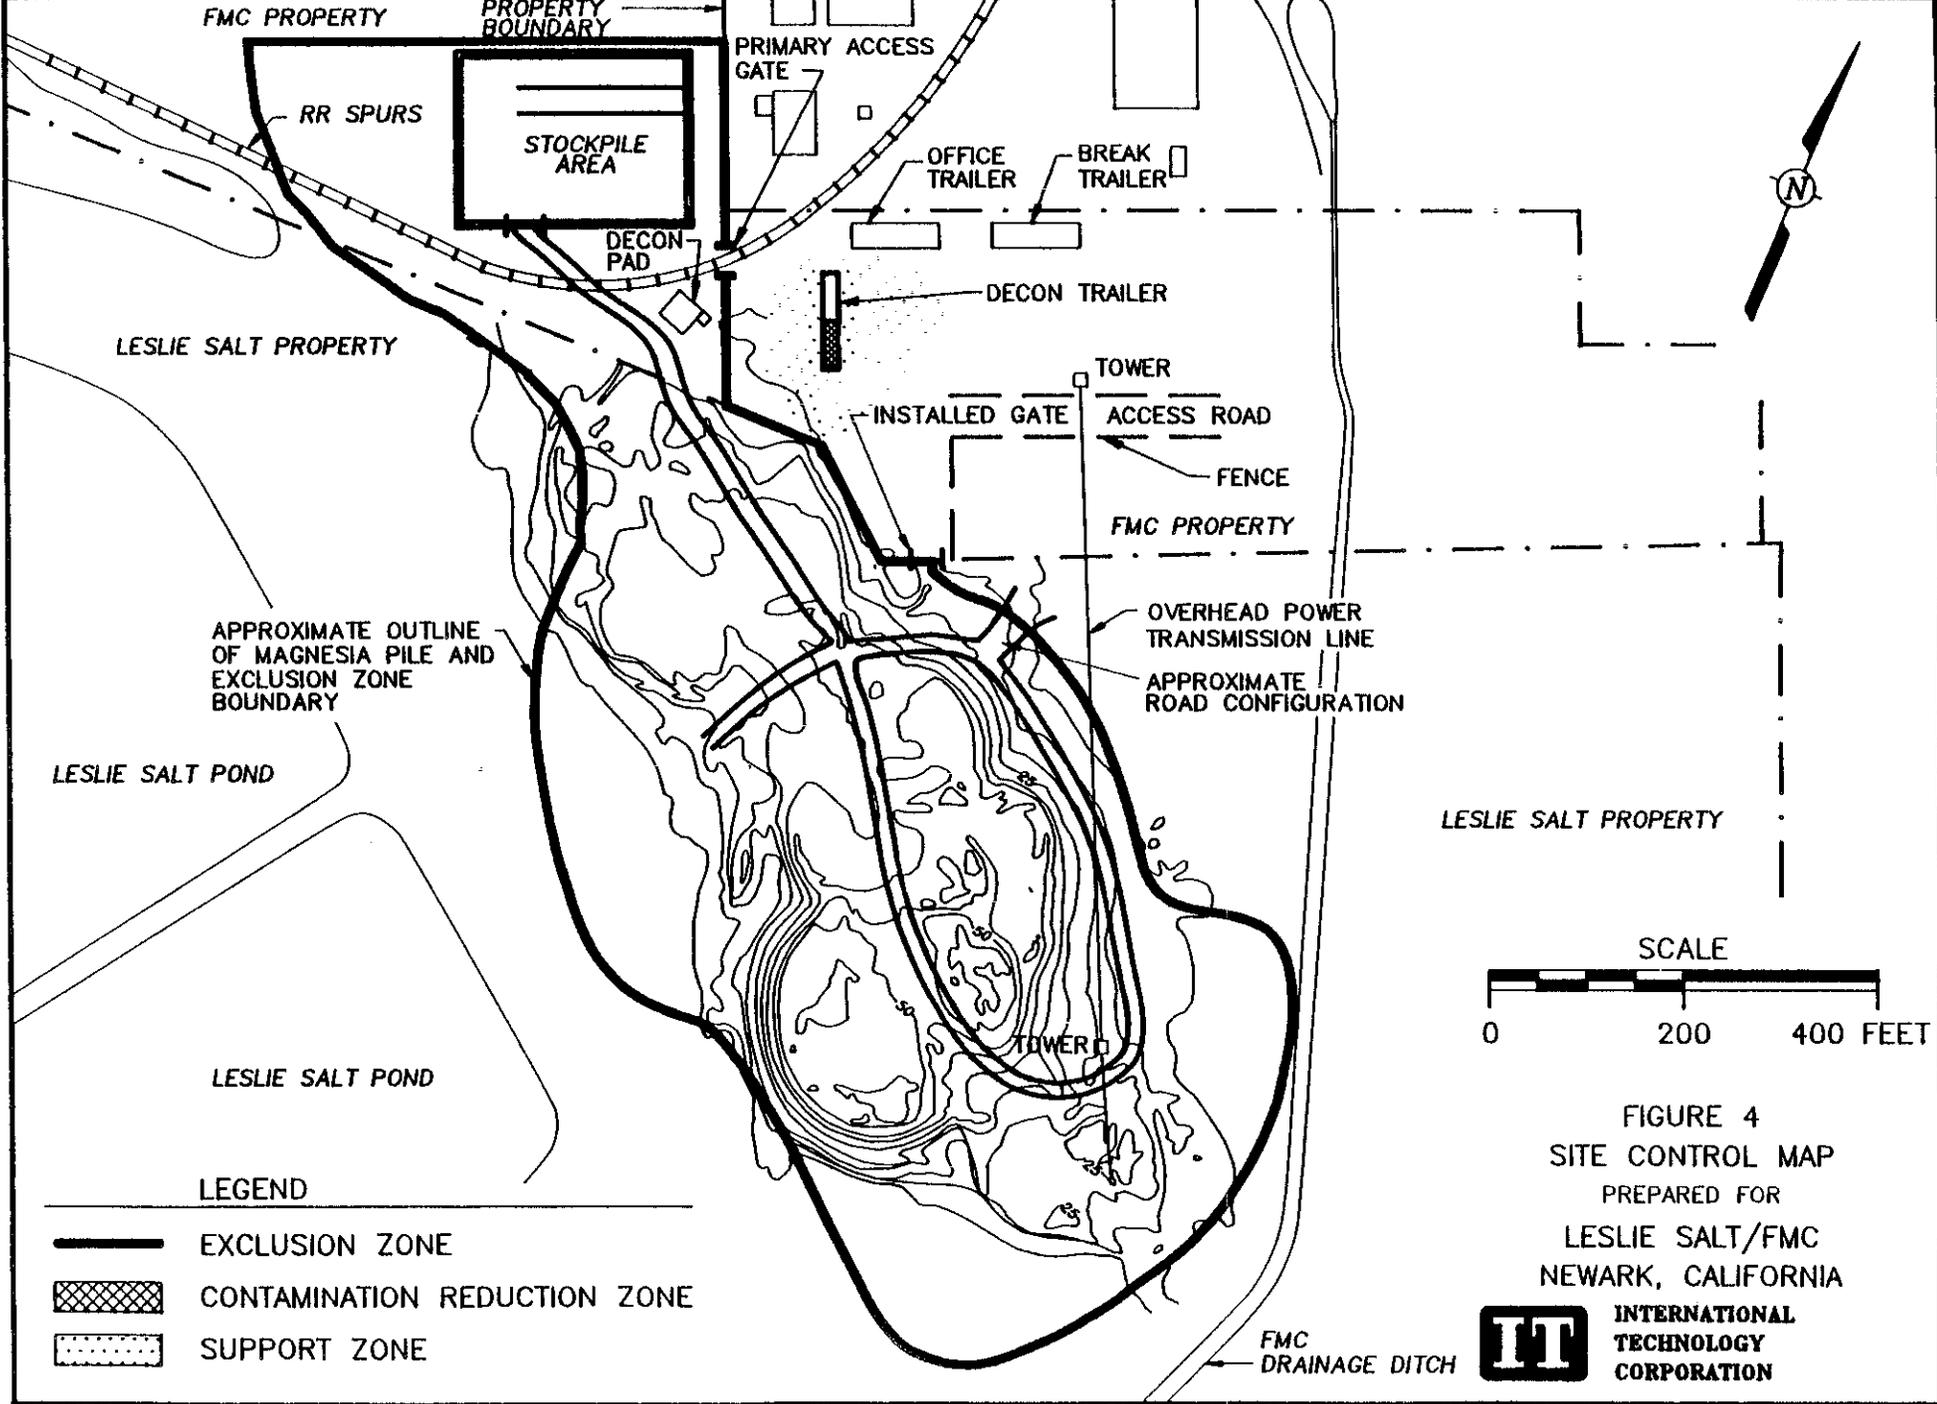
FIGURE 4  
 SITE CONTROL MAP  
 PREPARED FOR  
 LESLIE SALT/FMC  
 NEWARK, CALIFORNIA

Only IT personnel and authorized visitors who had completed 40 hours OSHA training and were equipped with the required personnel protective equipment were allowed to enter this zone. Access to the exclusion zone was monitored and a log of all persons entering this area was maintained.

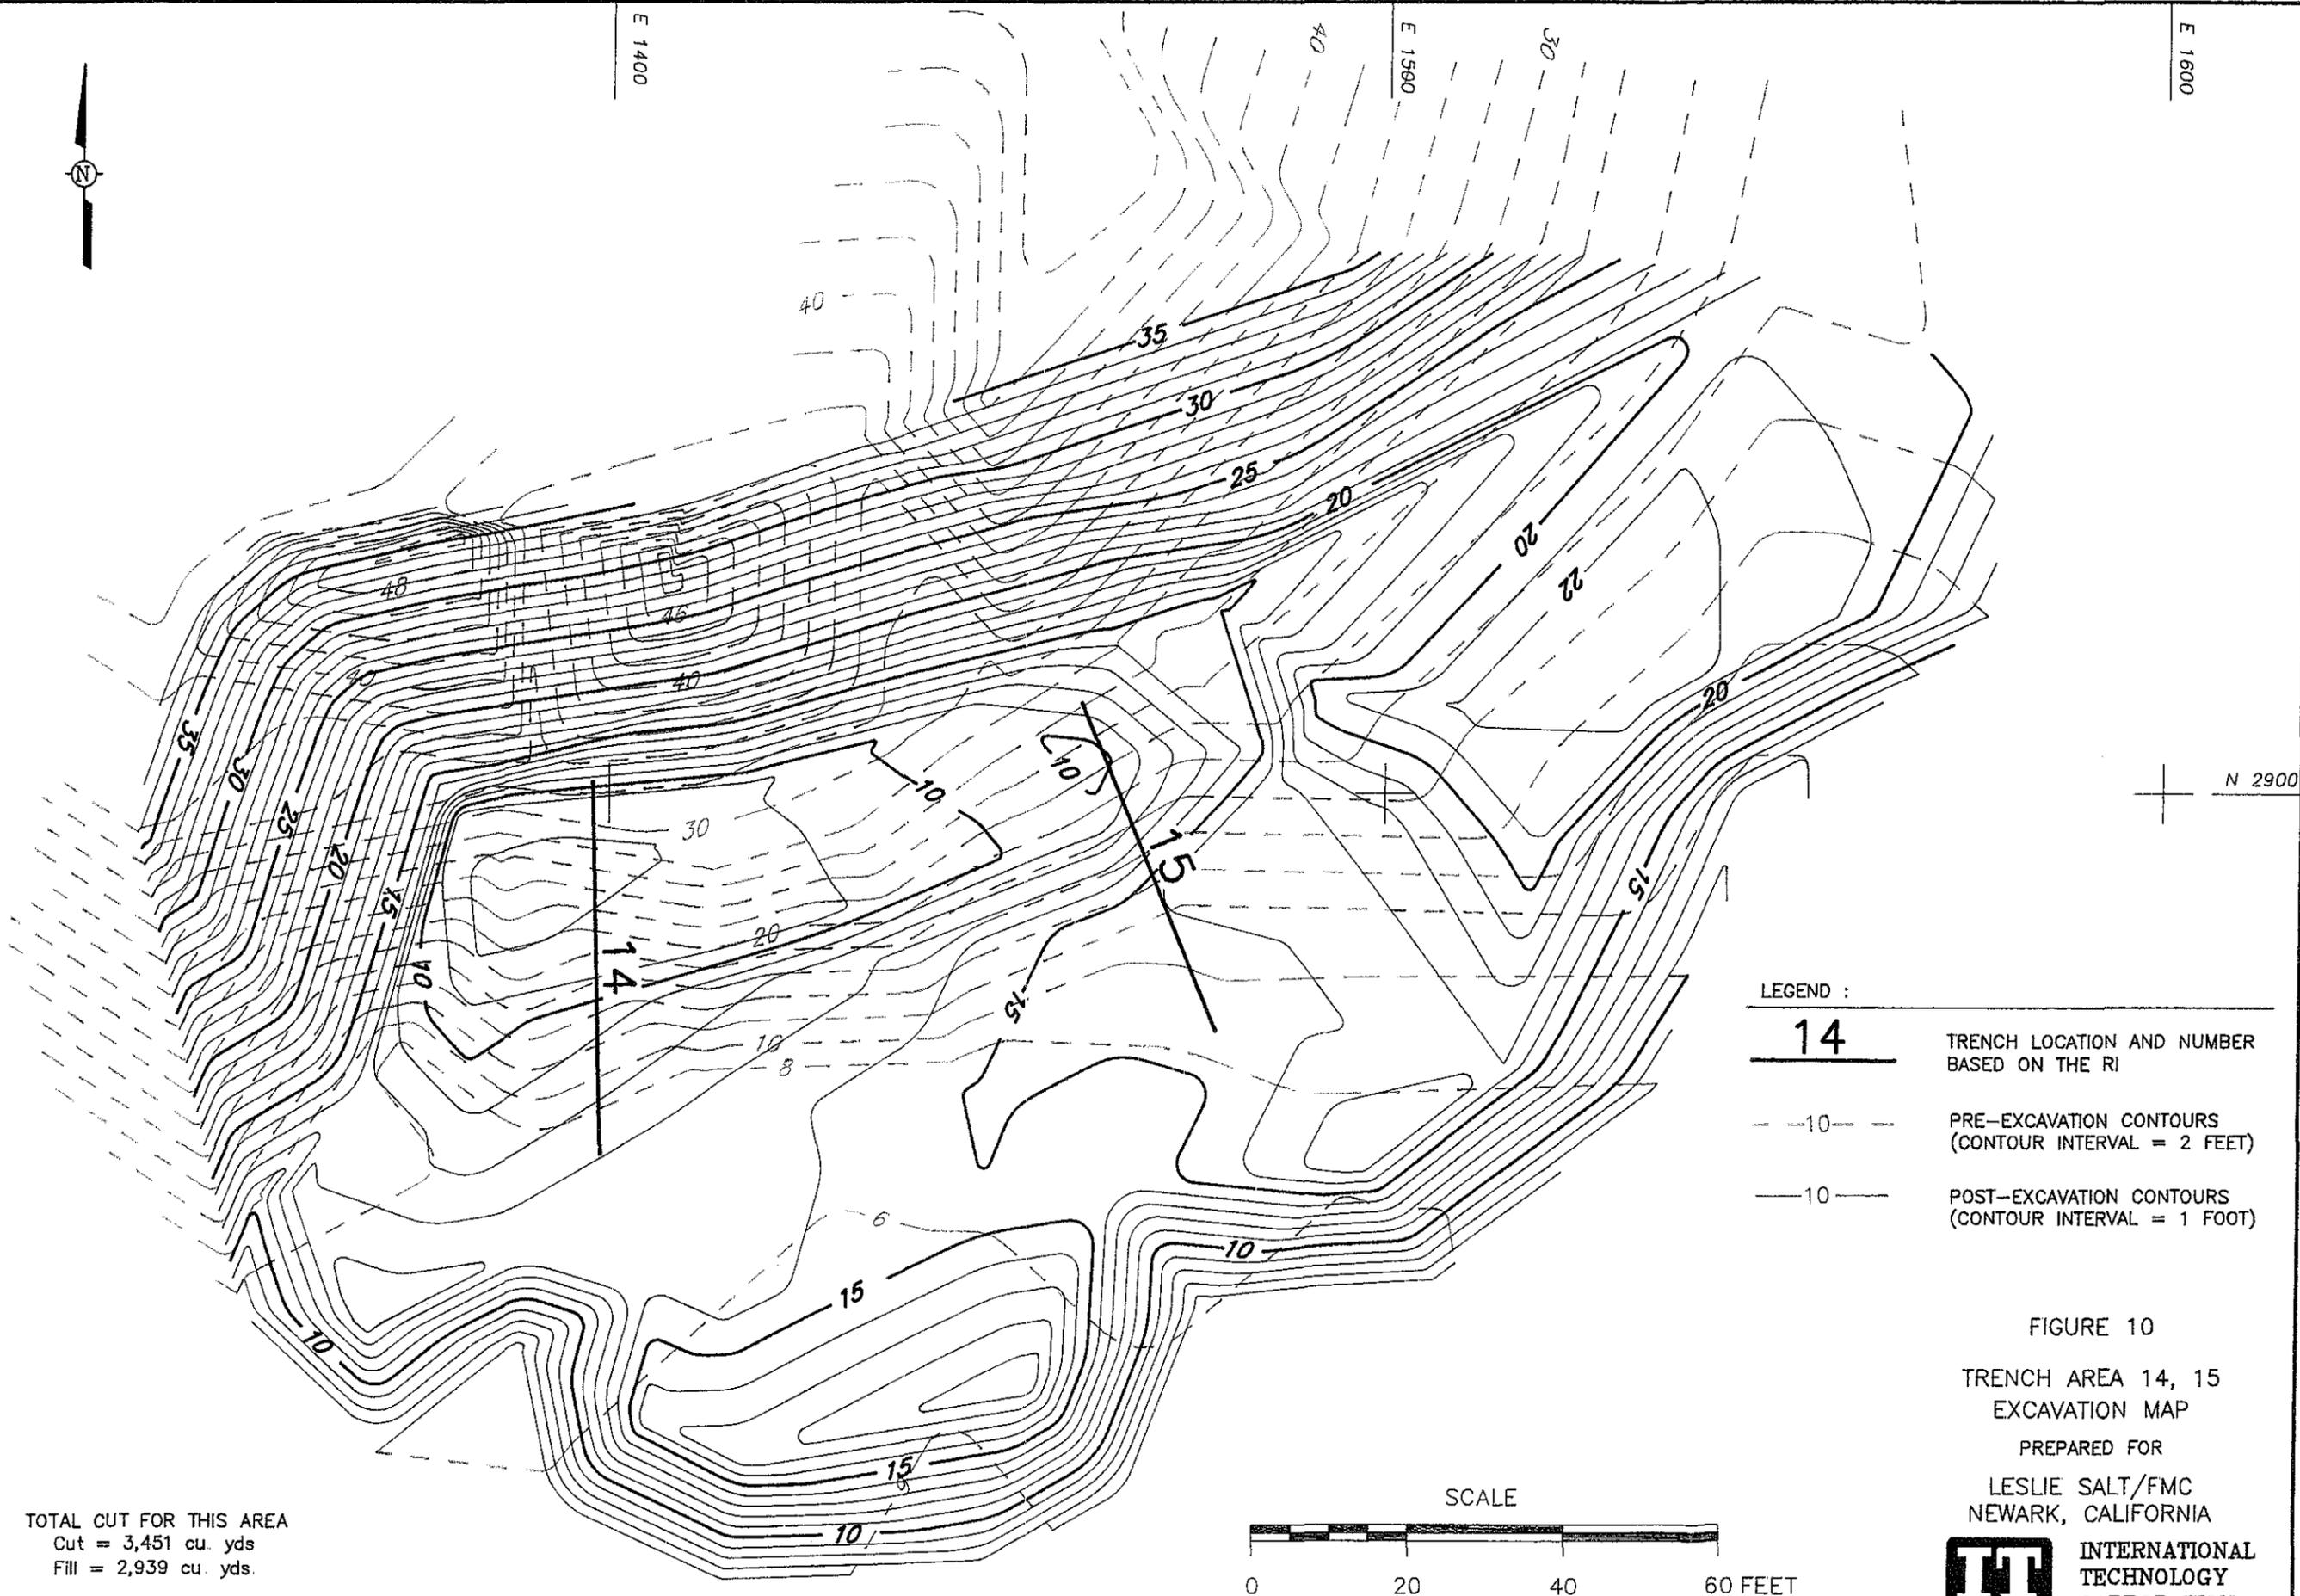
DRAWN BY J.A.C. 8-28-91 CHECKED BY F.M.C. 8-30-91 APPROVED BY F.M.C. 09/09/91  
 DRAWING NUMBER 142468-B9

TOTAL CUT FOR THIS AREA  
 Cut = 3,451 cu. yds  
 Fill = 2,939 cu. yds.

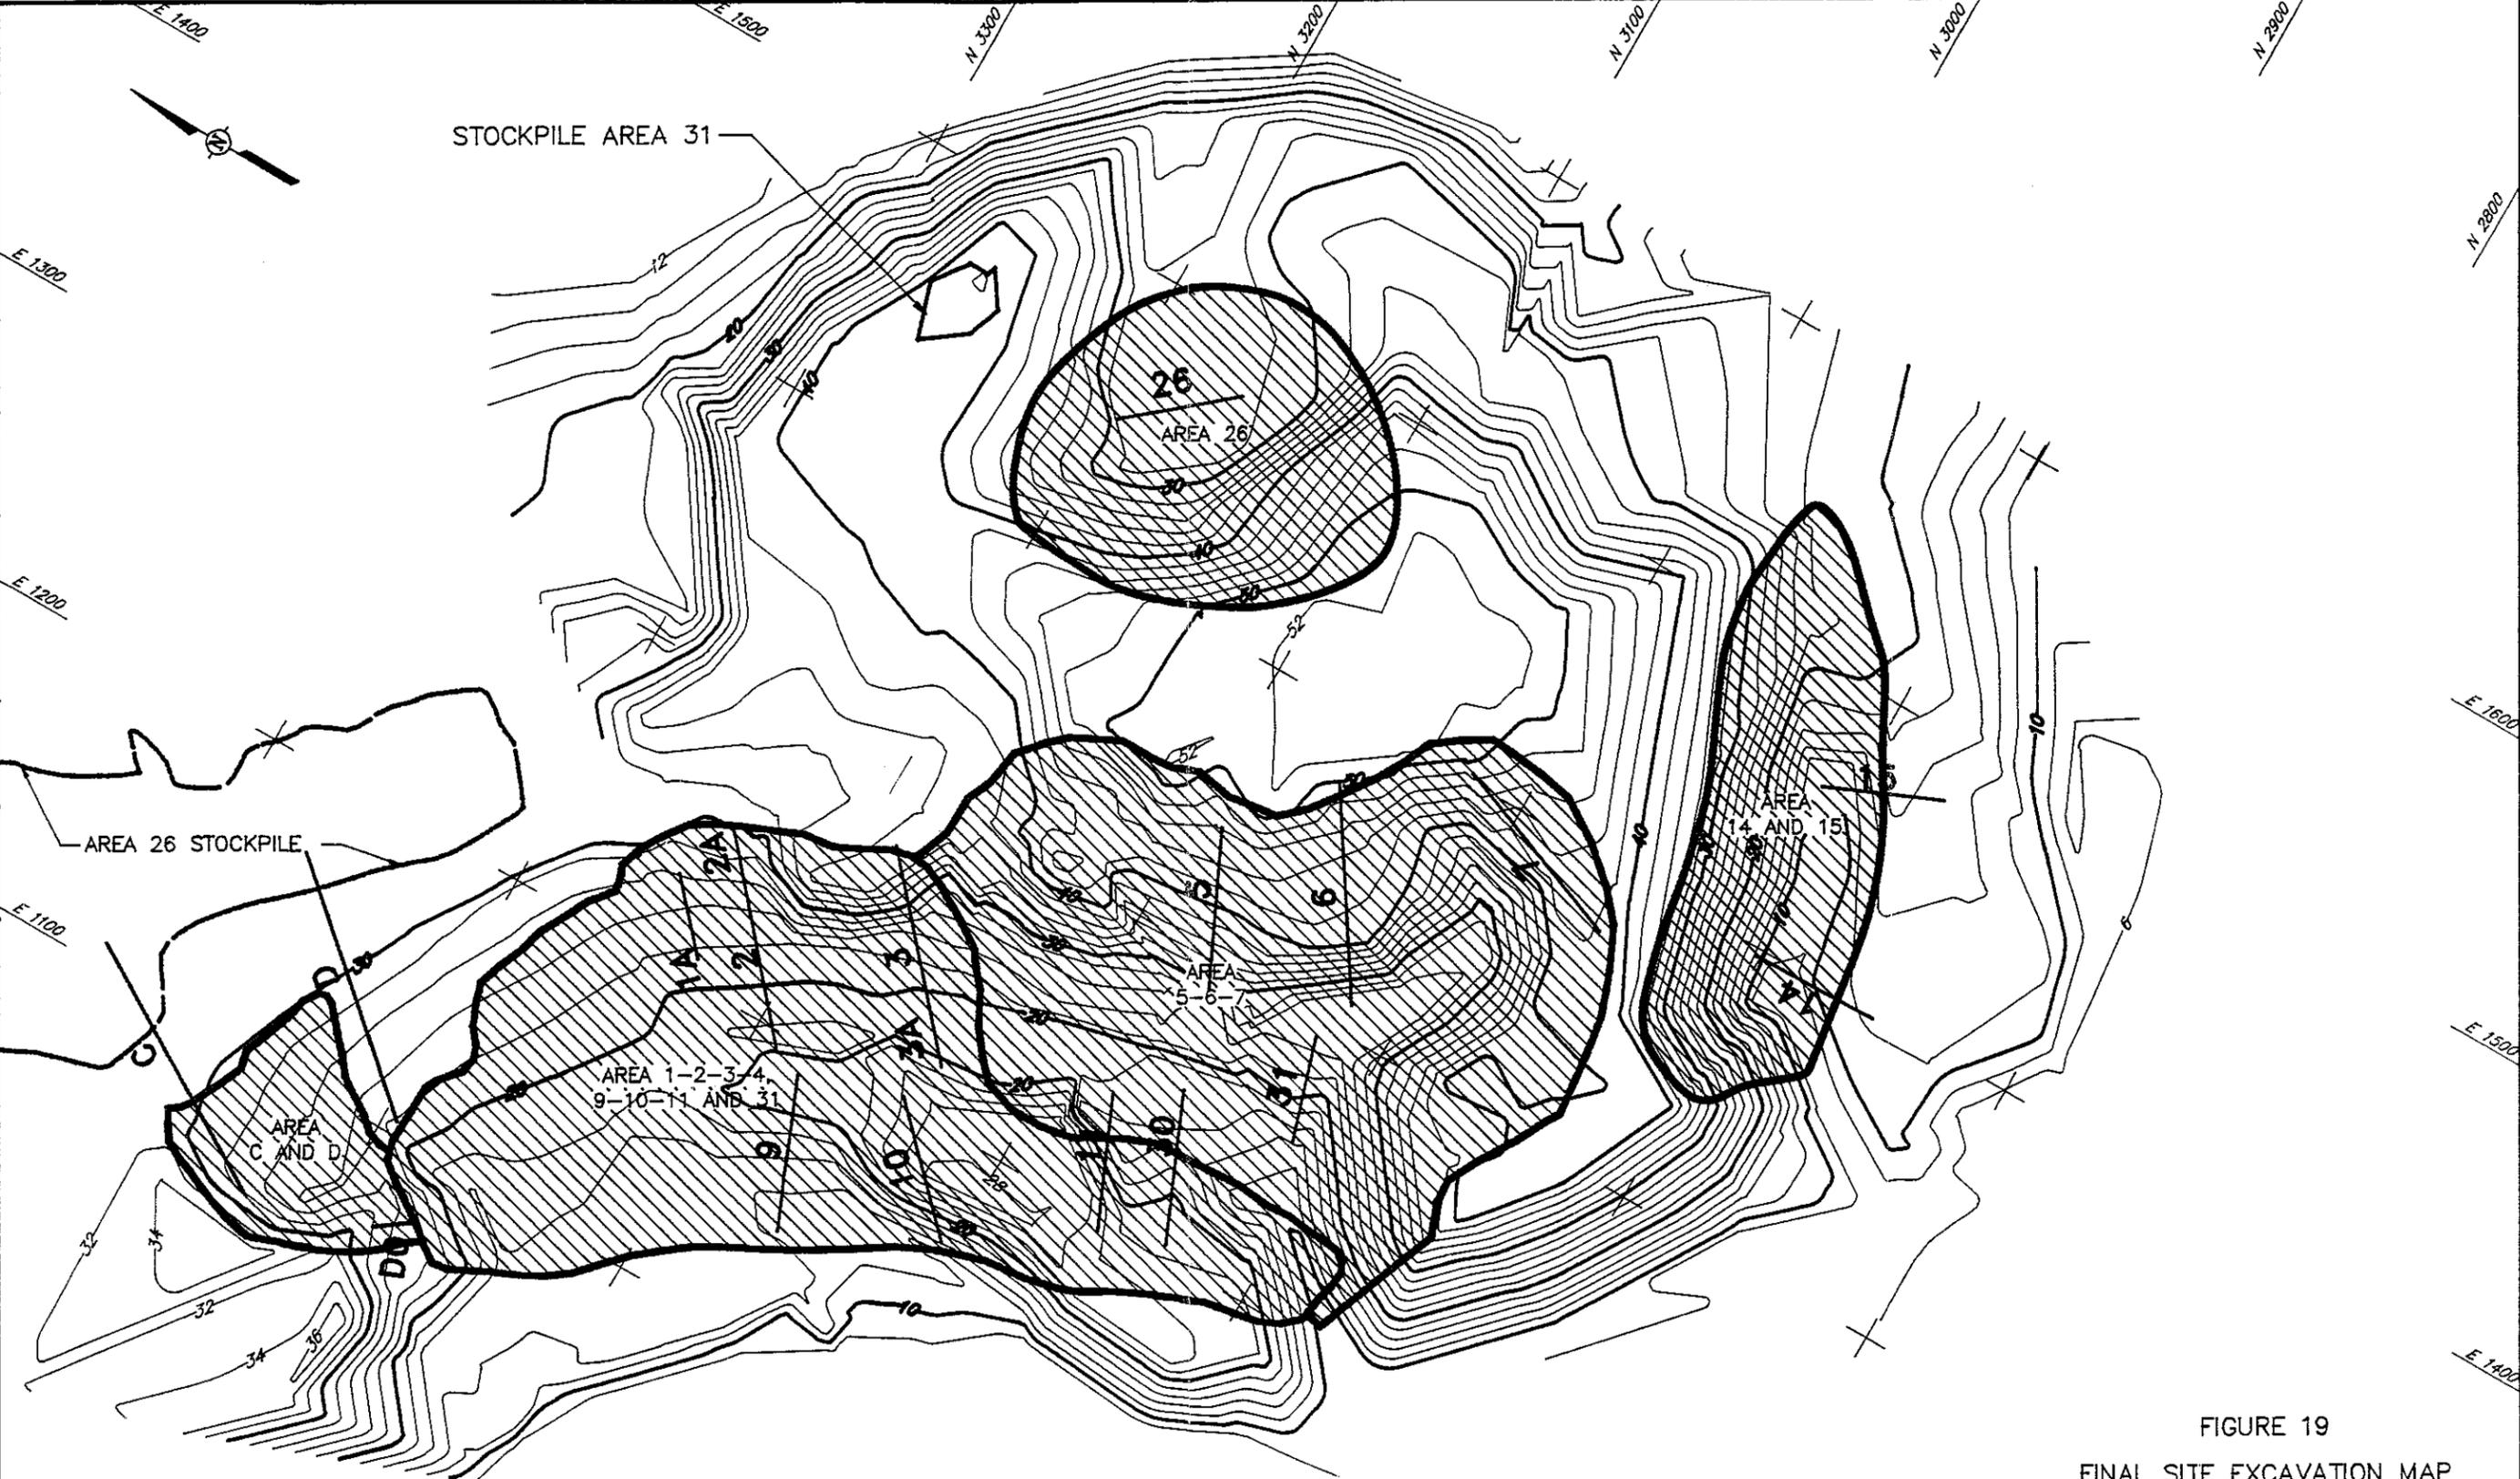
FIGURE 19  
 FINAL SITE EXCAVATION MAP  
 PREPARED FOR  
 LESLIE SALT/FMC  
 NEWARK, CALIFORNIA

The final site excavation configuration is shown on Figure 19, prior to the final grading and contouring. Excavated, uncontaminated magnesite overburden material was used to backfill the excavations. The upper two to three feet of the backfill material was compacted by several passes of the dozer to minimize future settlement. The excavated areas were graded to optimize rainfall runoff. A large swath was cut through the western excavation wall of Trench Area 5, 6, and 7 to promote positive drainage. The final as-built topography is shown in Figure 20. Figure 20 also shows the final graded locations of the material excavated from Trenches 26 and 31.

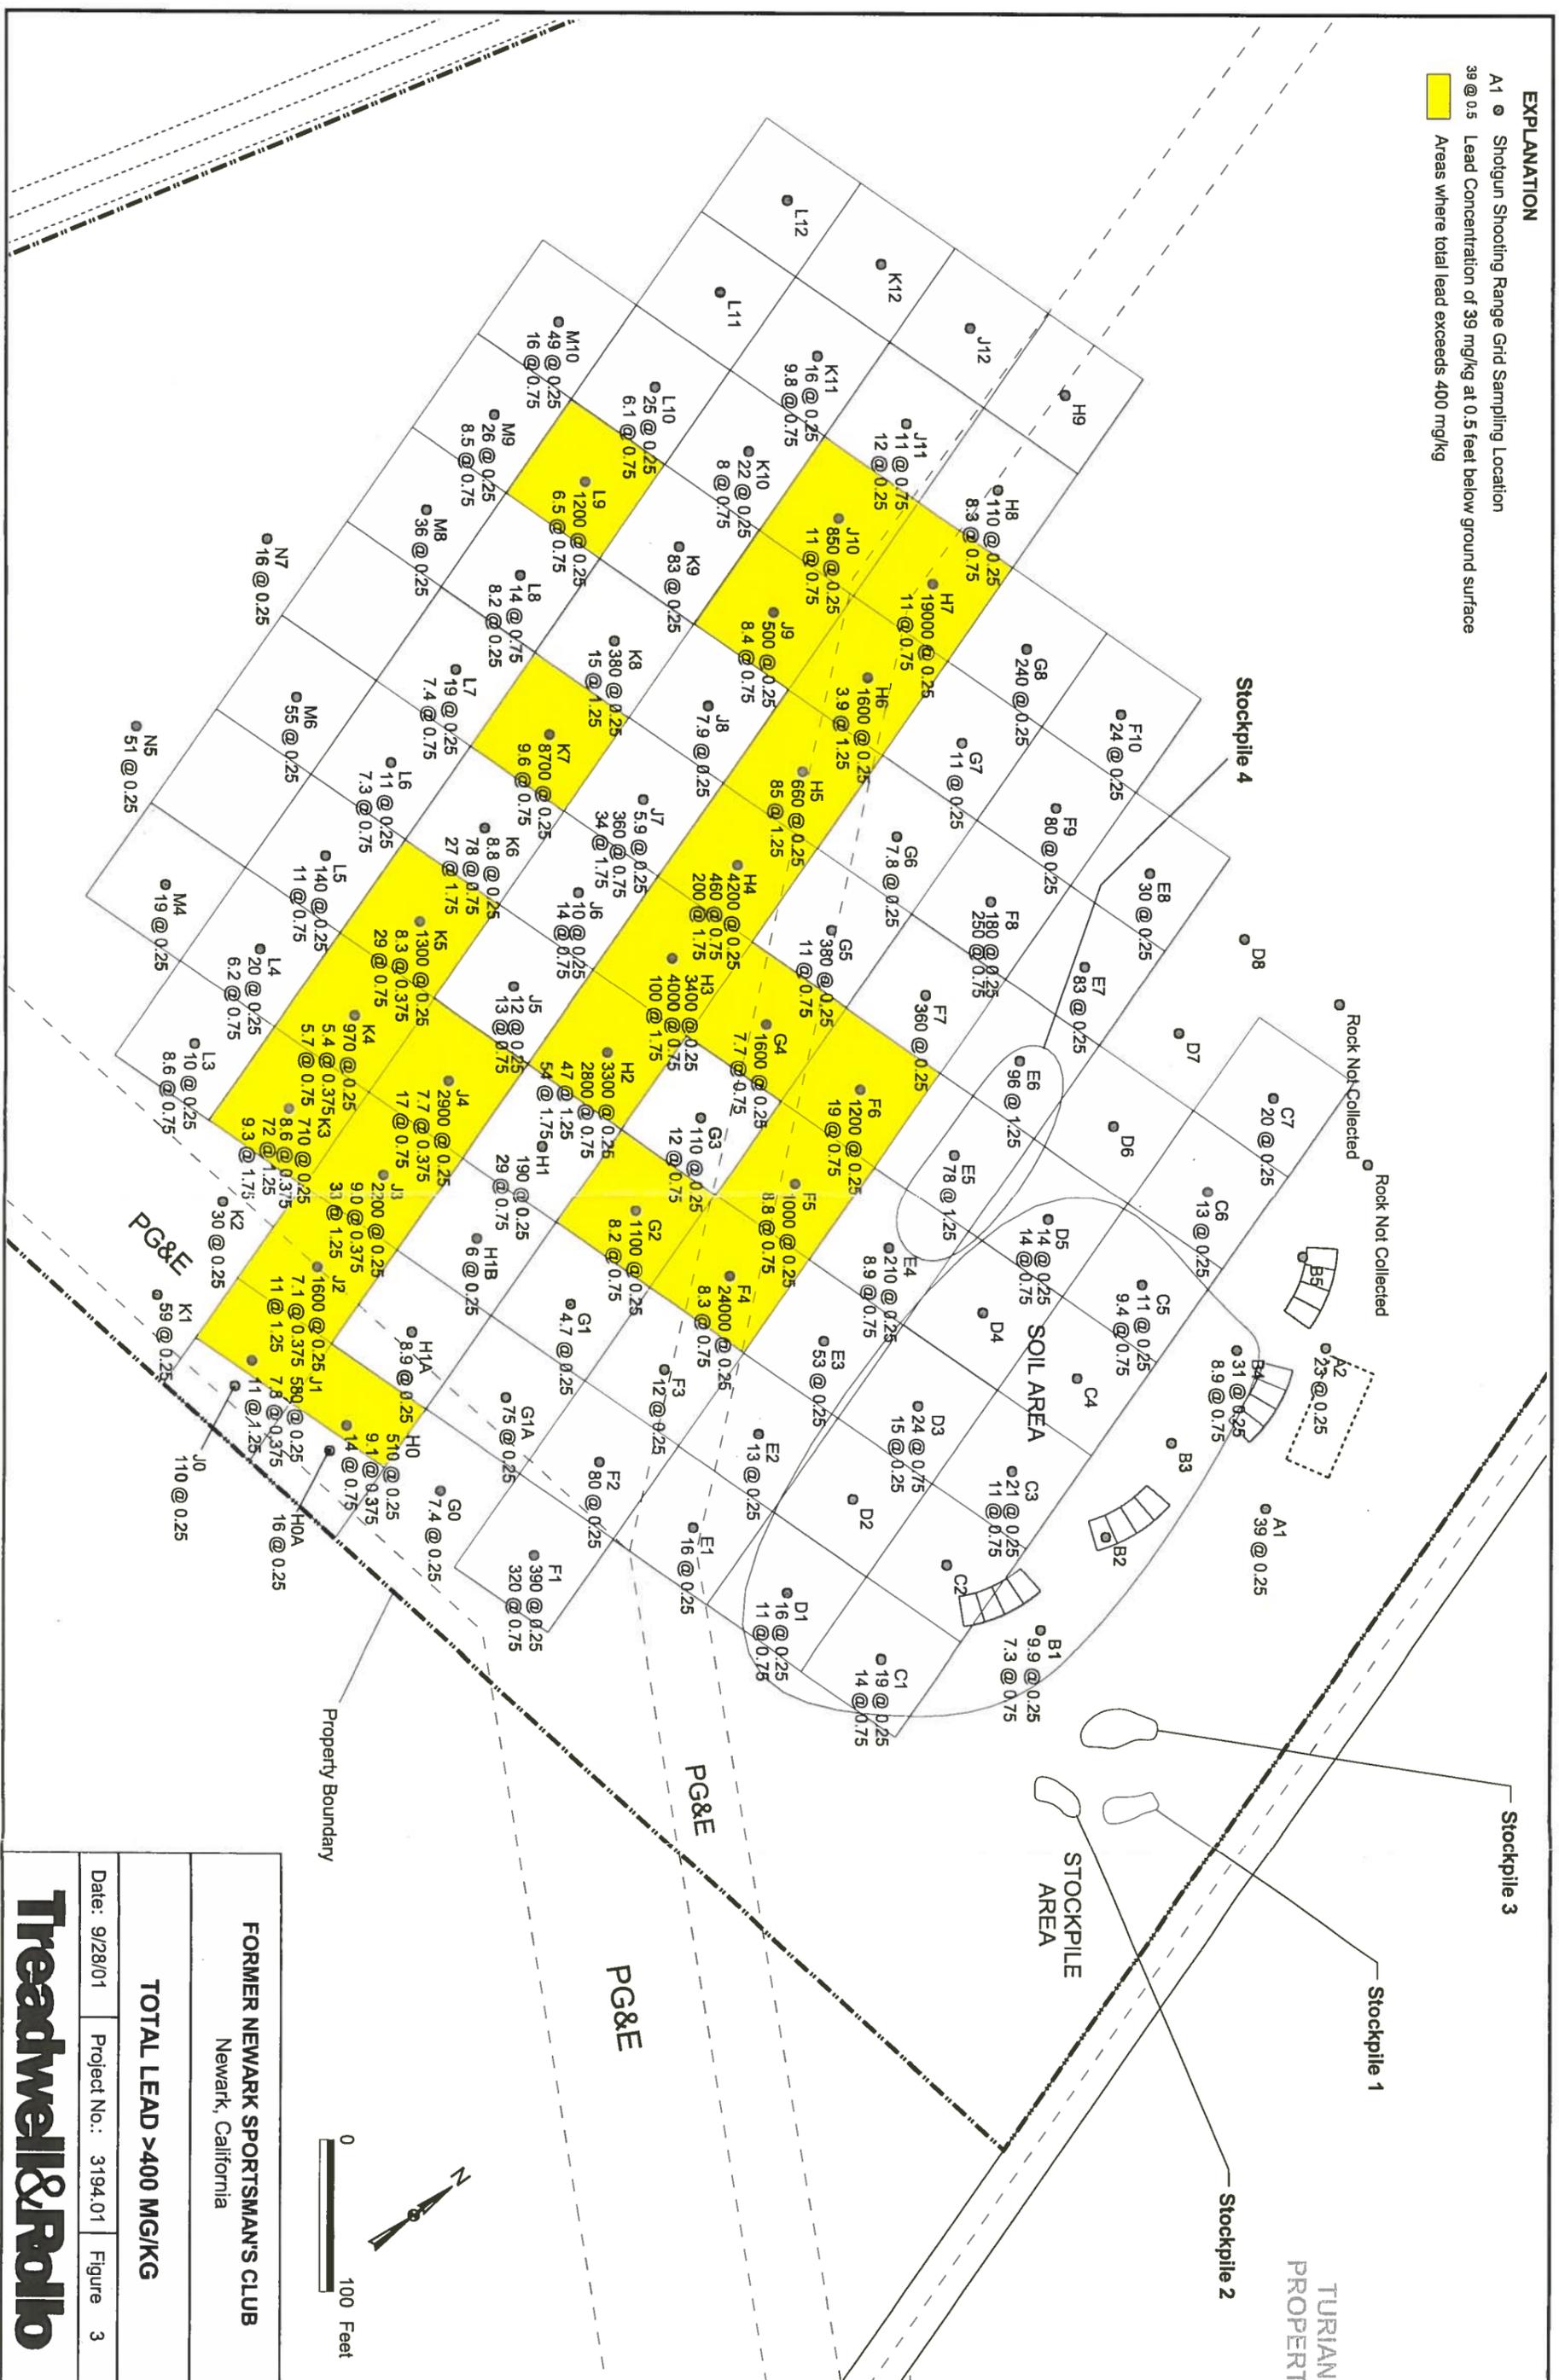
**TOTAL LEAD >400 MG/KG**

- A1 ● Shotgun Shooting Range Grid Sampling Location
- 39 @ 0.5 ● Lead Concentration of 39 mg/kg at 0.5 feet below ground surface
- Areas where total lead exceeds 400 mg/kg

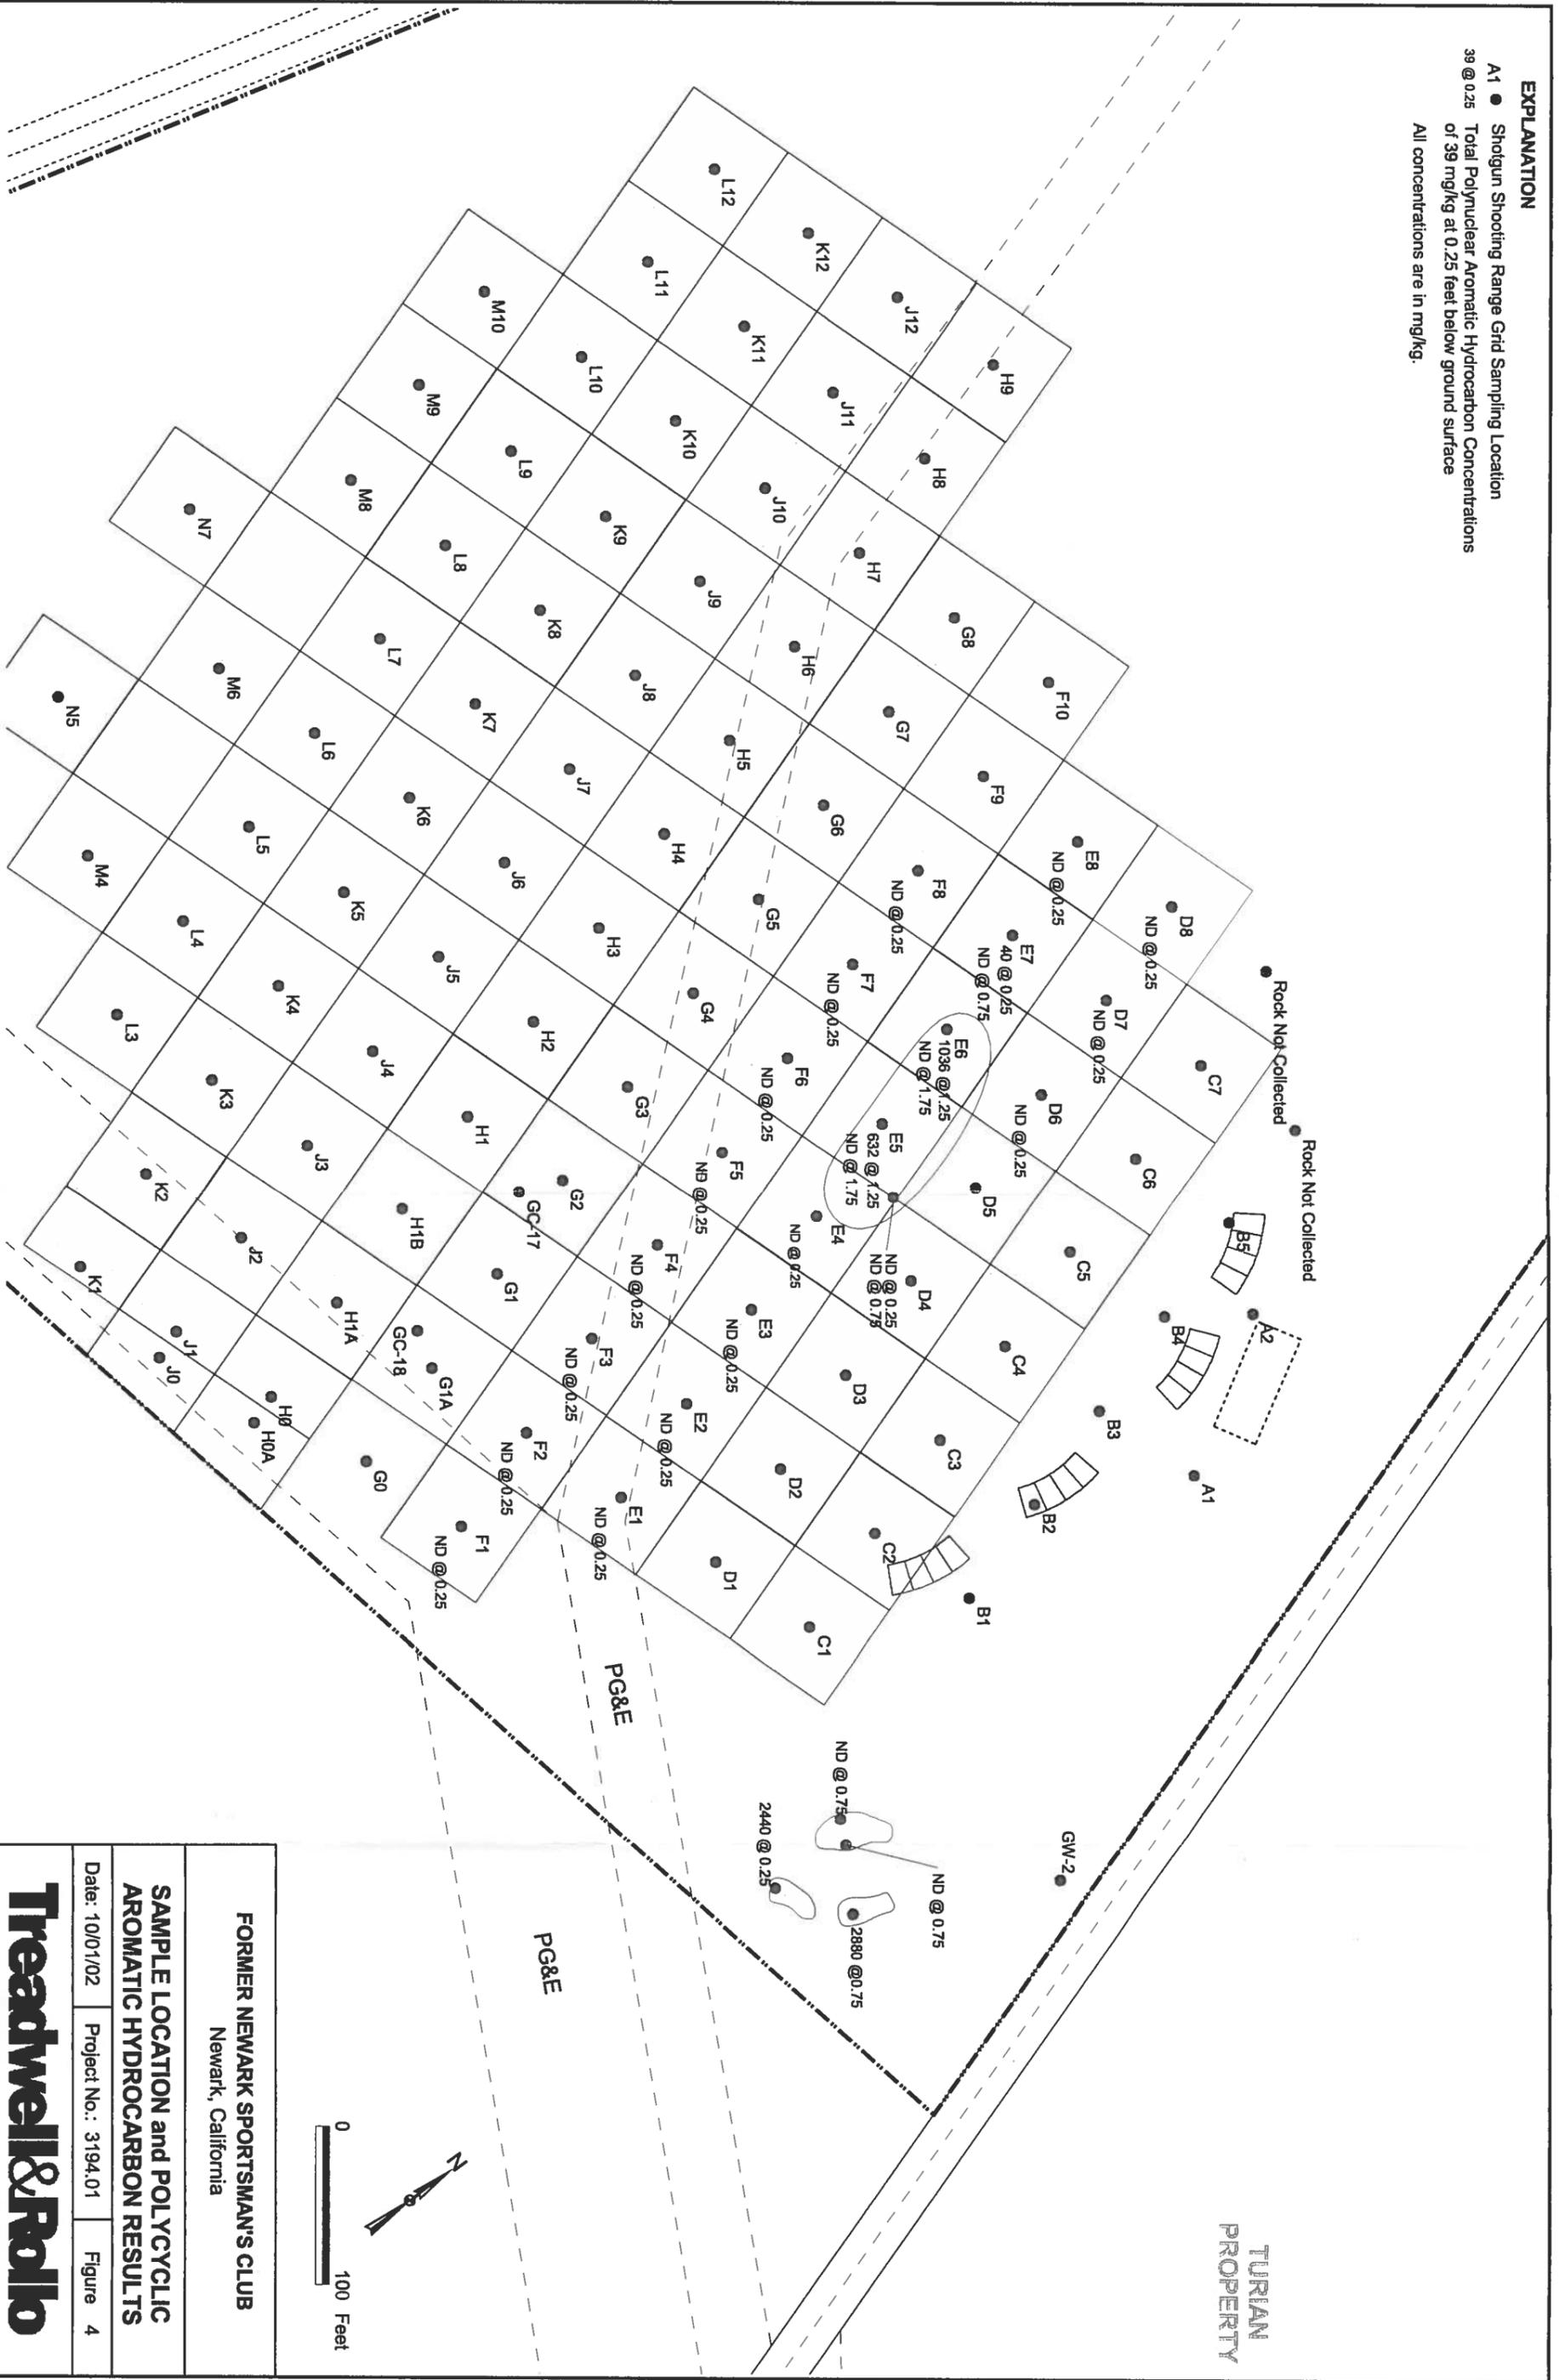
**SAMPLE LOCATION and POLYCYCLIC AROMATIC HYDROCARBON RESULTS**

**EXPLANATION**  
 A1 ● Shotgun Shooting Range Grid Sampling Location  
 39 @ 0.25 Total Polynuclear Aromatic Hydrocarbon Concentrations  
 of 39 mg/kg at 0.25 feet below ground surface  
 All concentrations are in mg/kg.

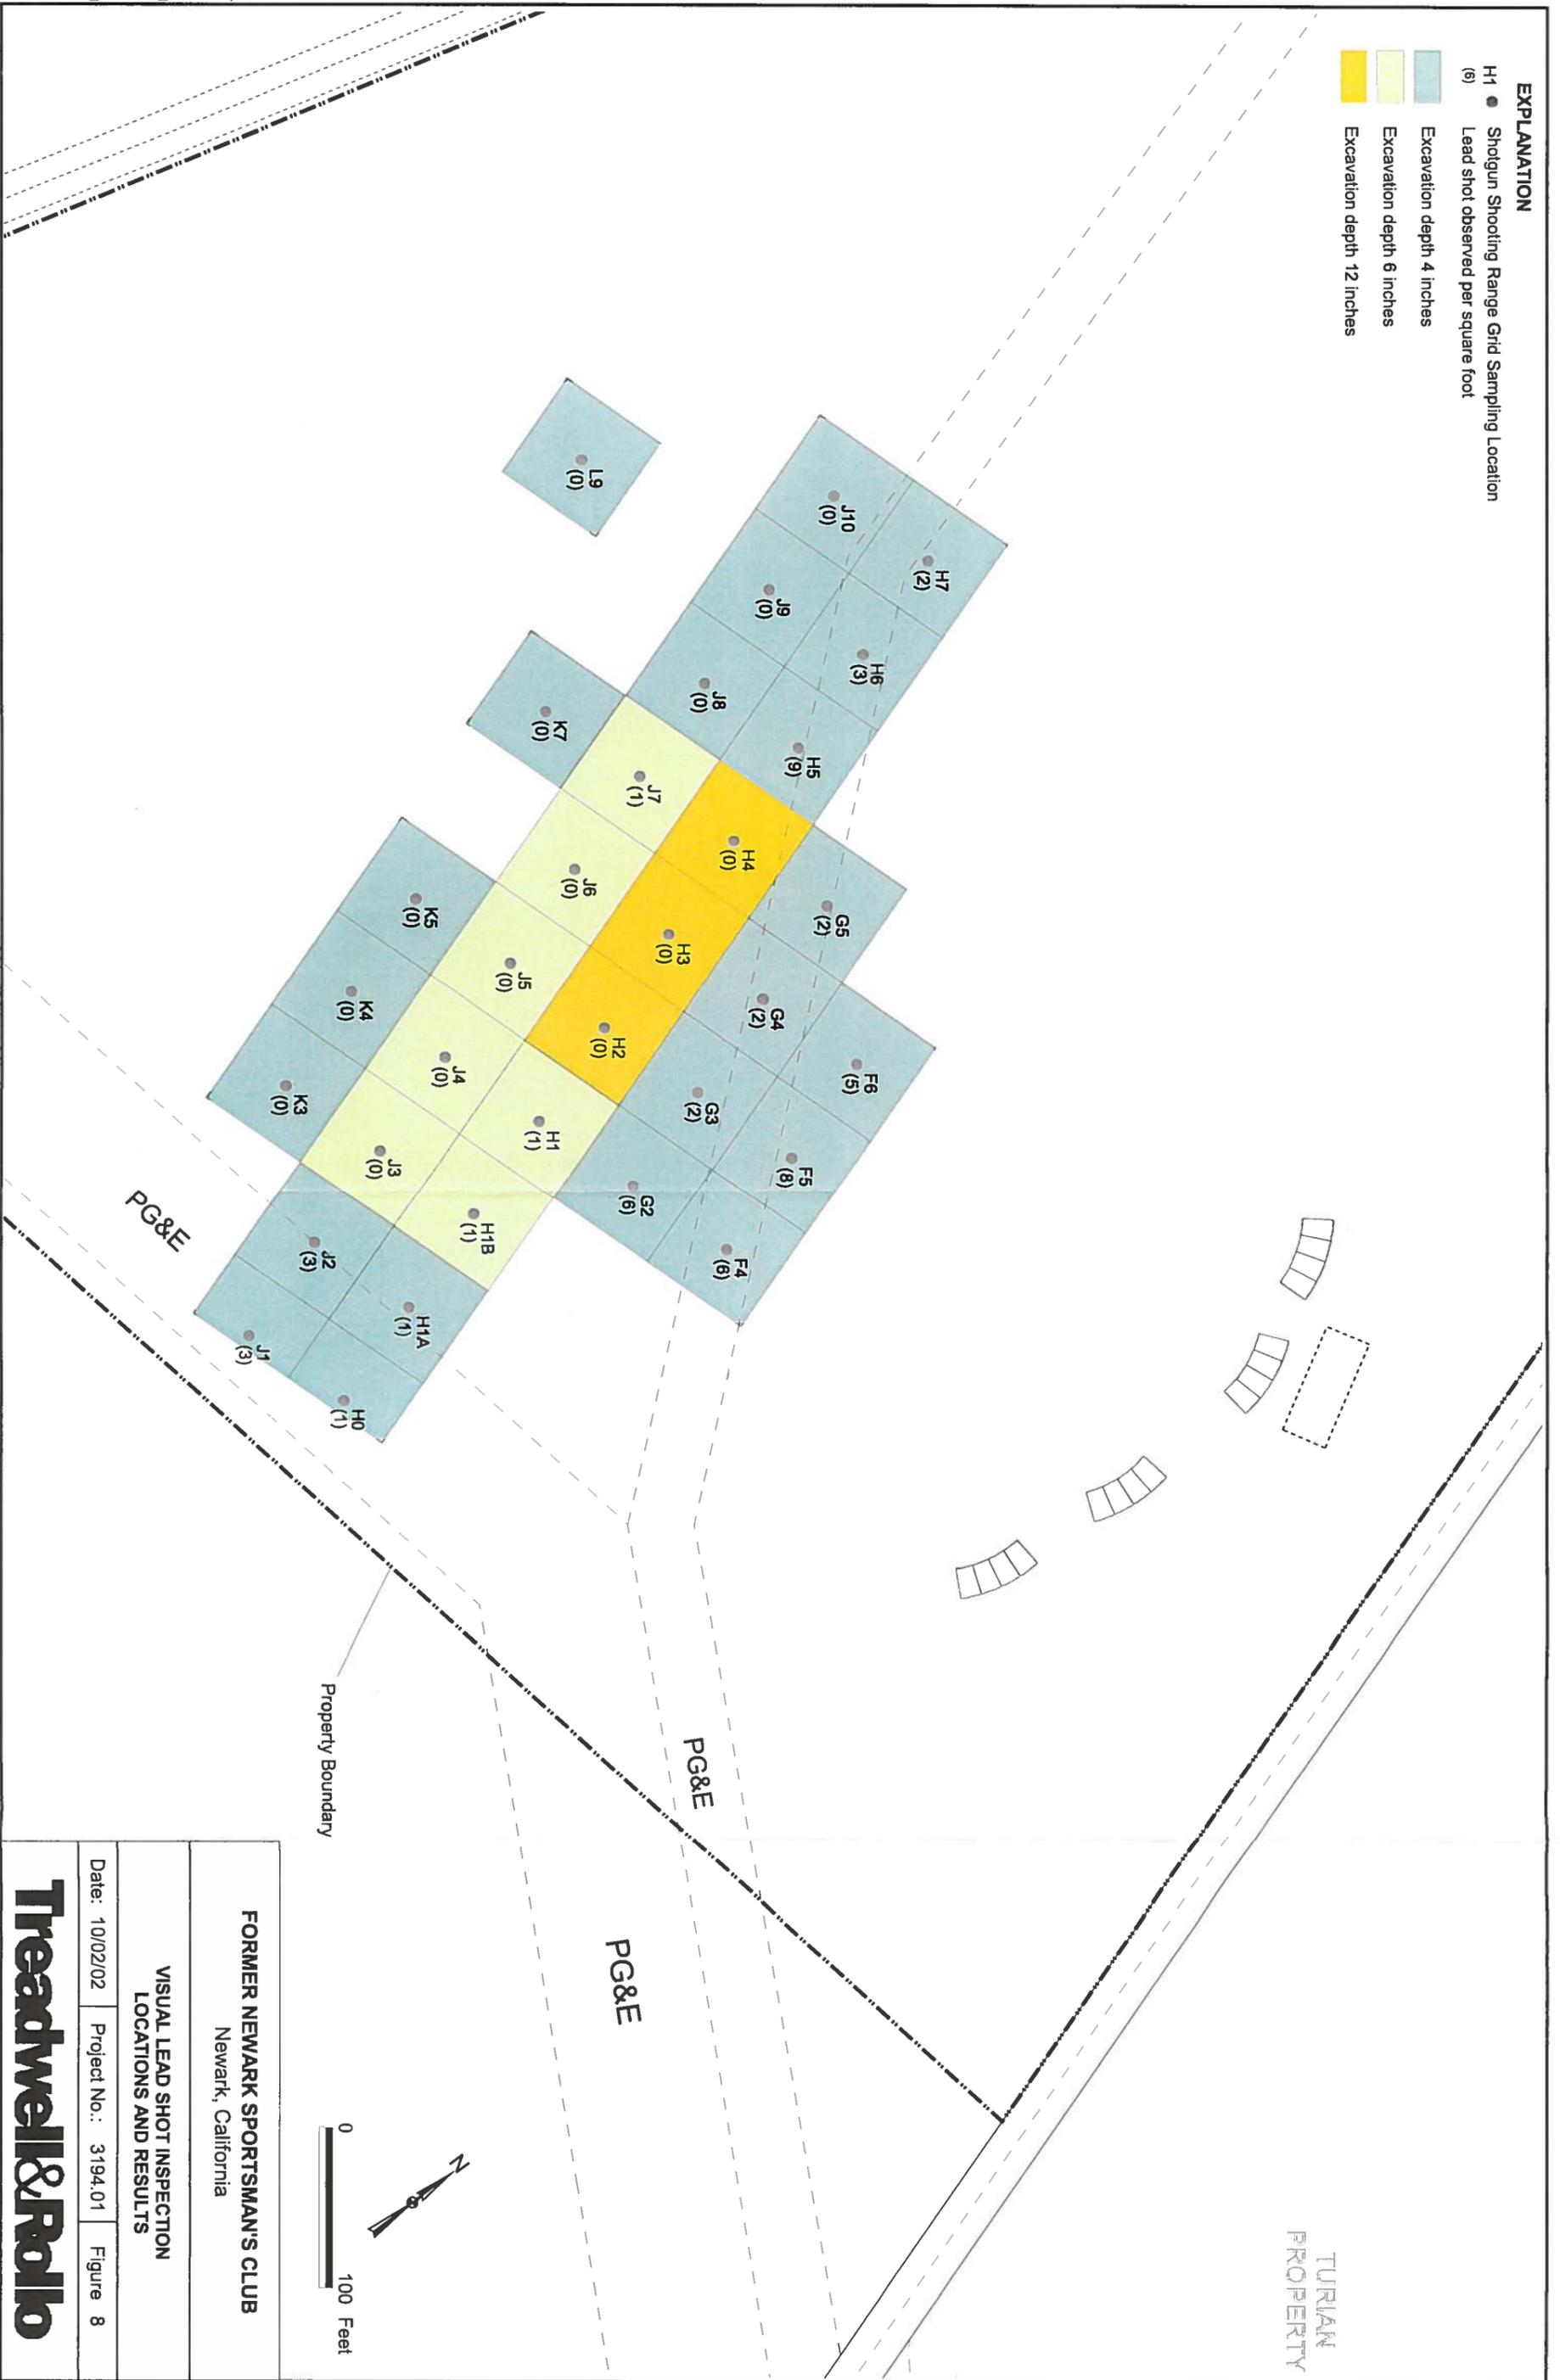
**VISUAL LEAD SHOT INSPECTION**  
 LOCATIONS AND RESULTS

- EXPLANATION**
- H1 ● Shotgun Shooting Range Grid Sampling Location
  - (#) Lead shot observed per square foot
  - Excavation depth 4 inches
  - Excavation depth 6 inches
  - Excavation depth 12 inches

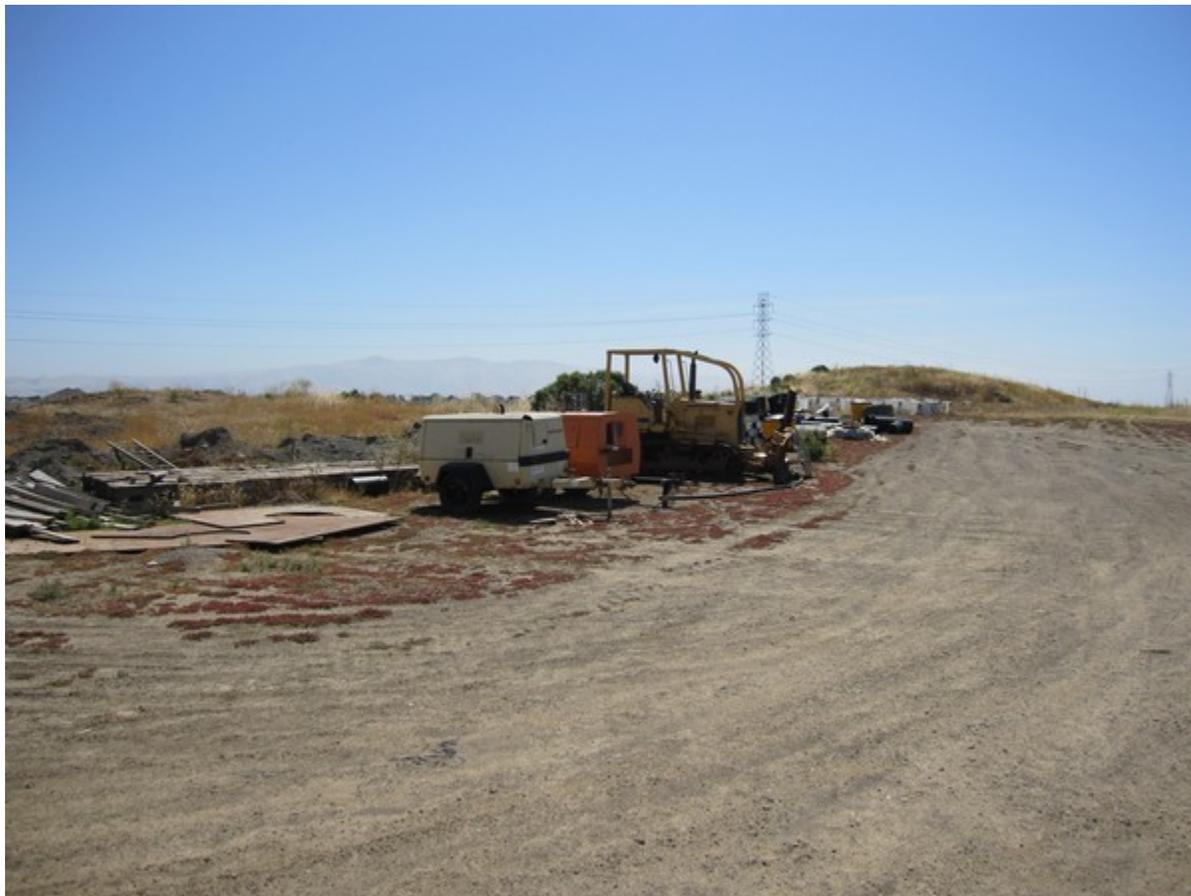
**Photograph 1:** Top of hill (former waste pile area) on northwest portion of the site. Contractor equipment storage items shown at center.
