ASTM PHASE I AND PHASE II  
ENVIRONMENTAL SITE ASSESSMENTS

**REPORT ON  
ASTM PHASE I ENVIRONMENTAL SITE ASSESSMENT  
CARGILL PROPERTY - 54.53-ACRE PARCEL  
SOUTHWEST OF HICKORY STREET AND  
ENTERPRISE DRIVE  
NEWARK, CALIFORNIA**

**File No. 40451-000  
January 2014**

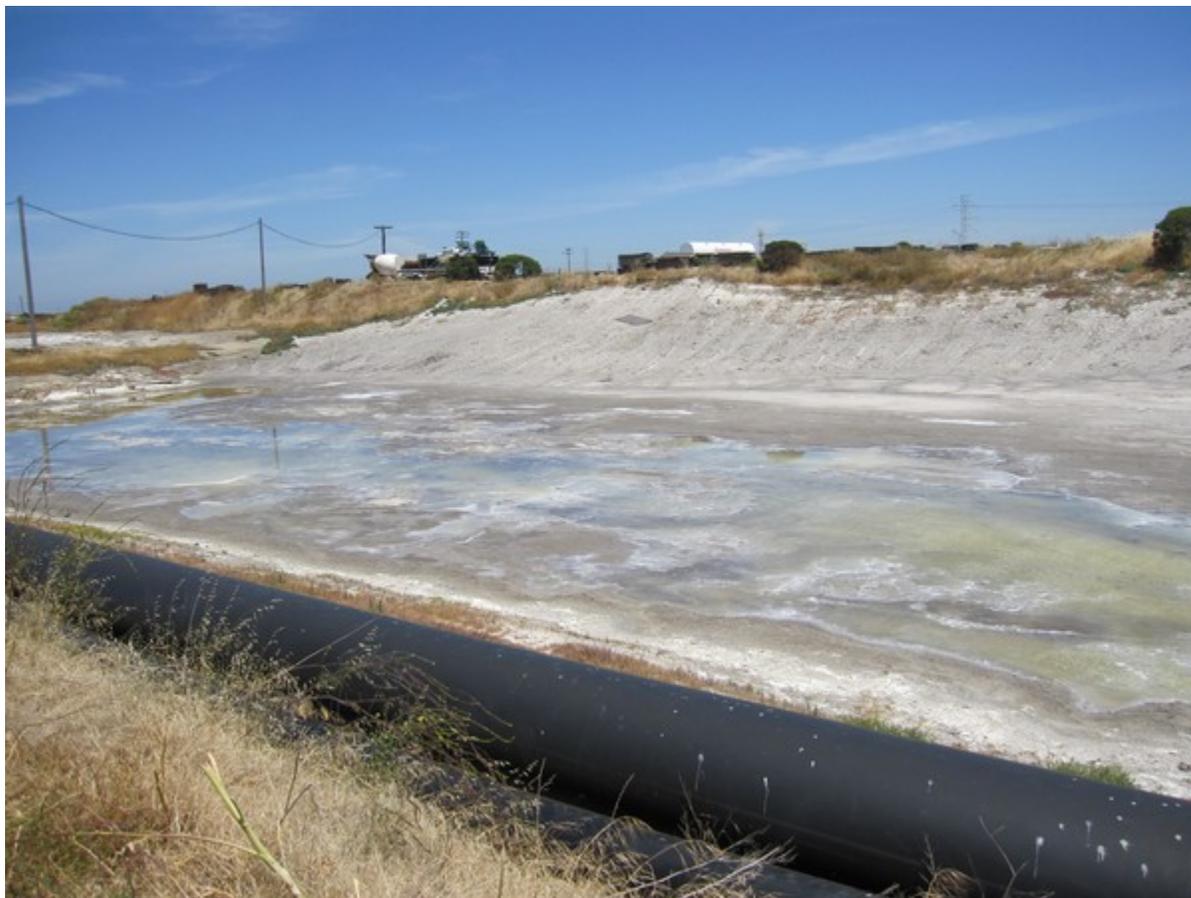
**Photograph 2:** White material, reportedly gypsum, at northwest corner of the site (southwest side of hill). A Cargill brine pipeline, located off-site, is shown at bottom.

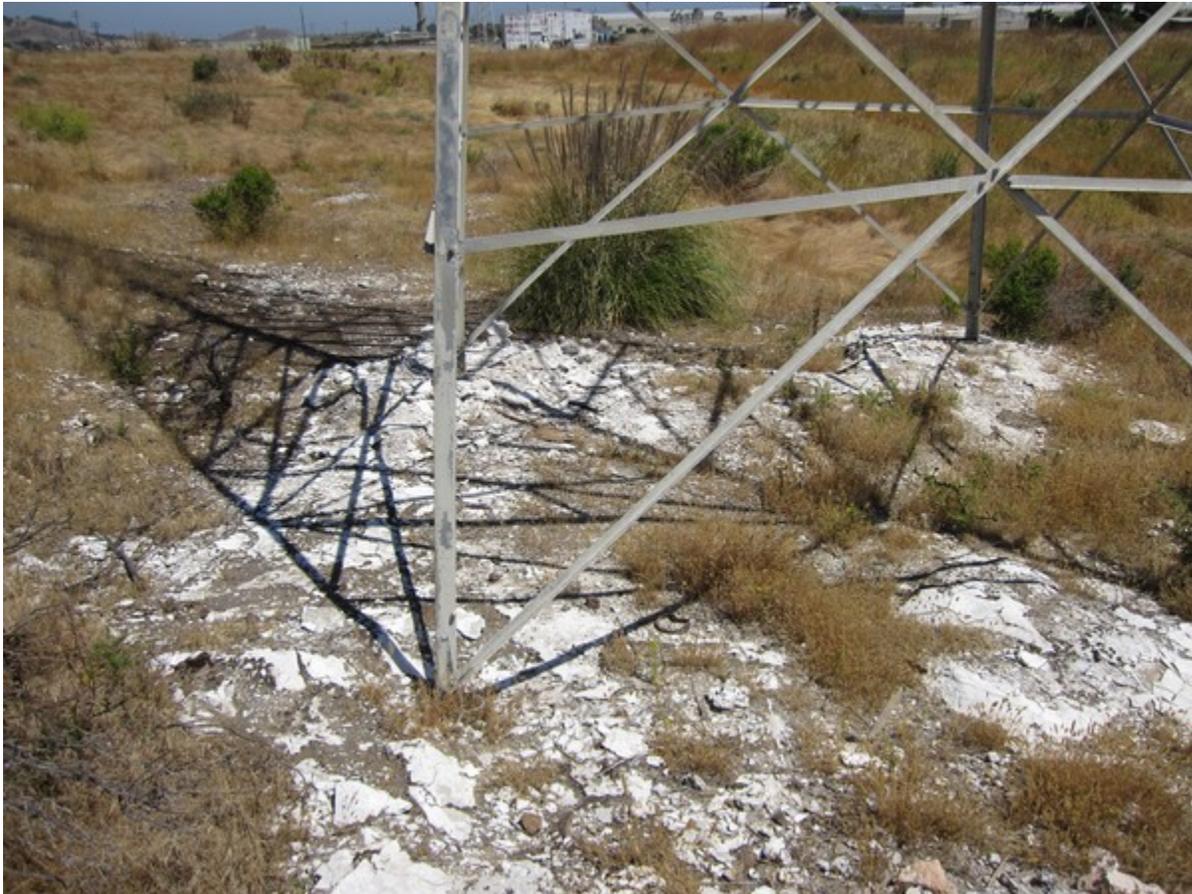
**Photograph 3:** Residual white material, presumably magnesia, below PG&E tower.

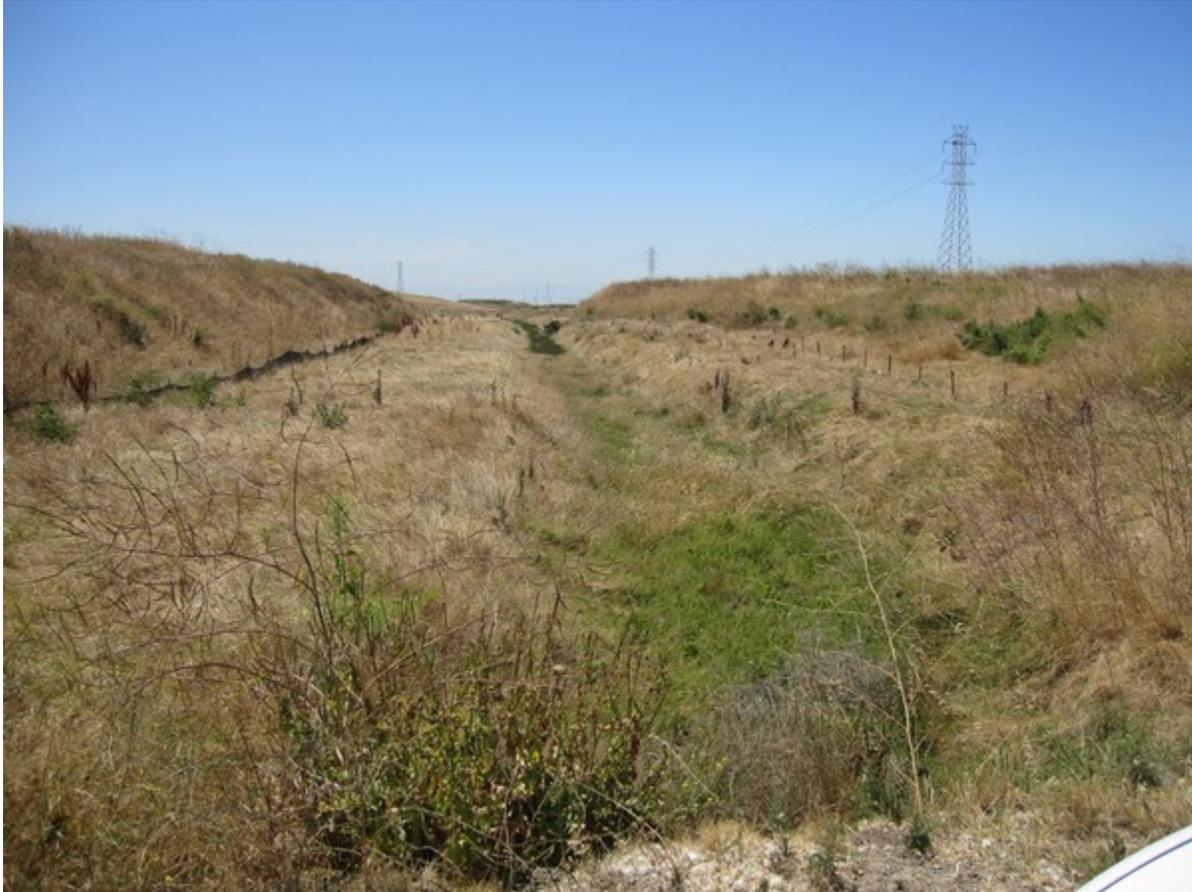
**Photograph 4:** E-1 drainage ditch (northern portion). Imported soil mounds are apparent on both sides the ditch.

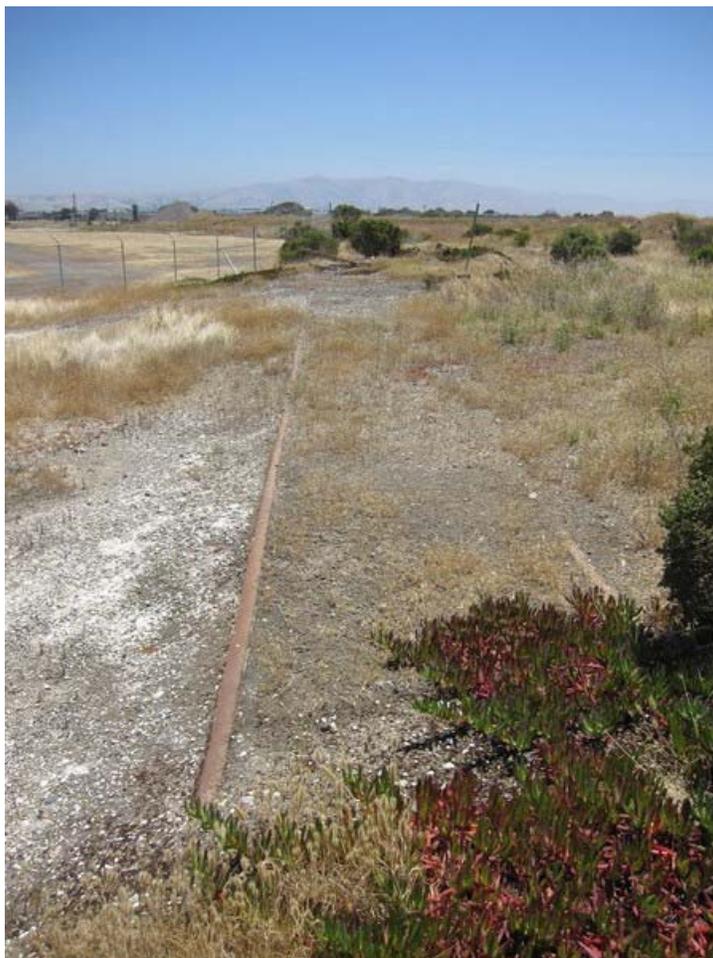
**Photograph 5:** Abandoned railroad track on northwest portion of site.

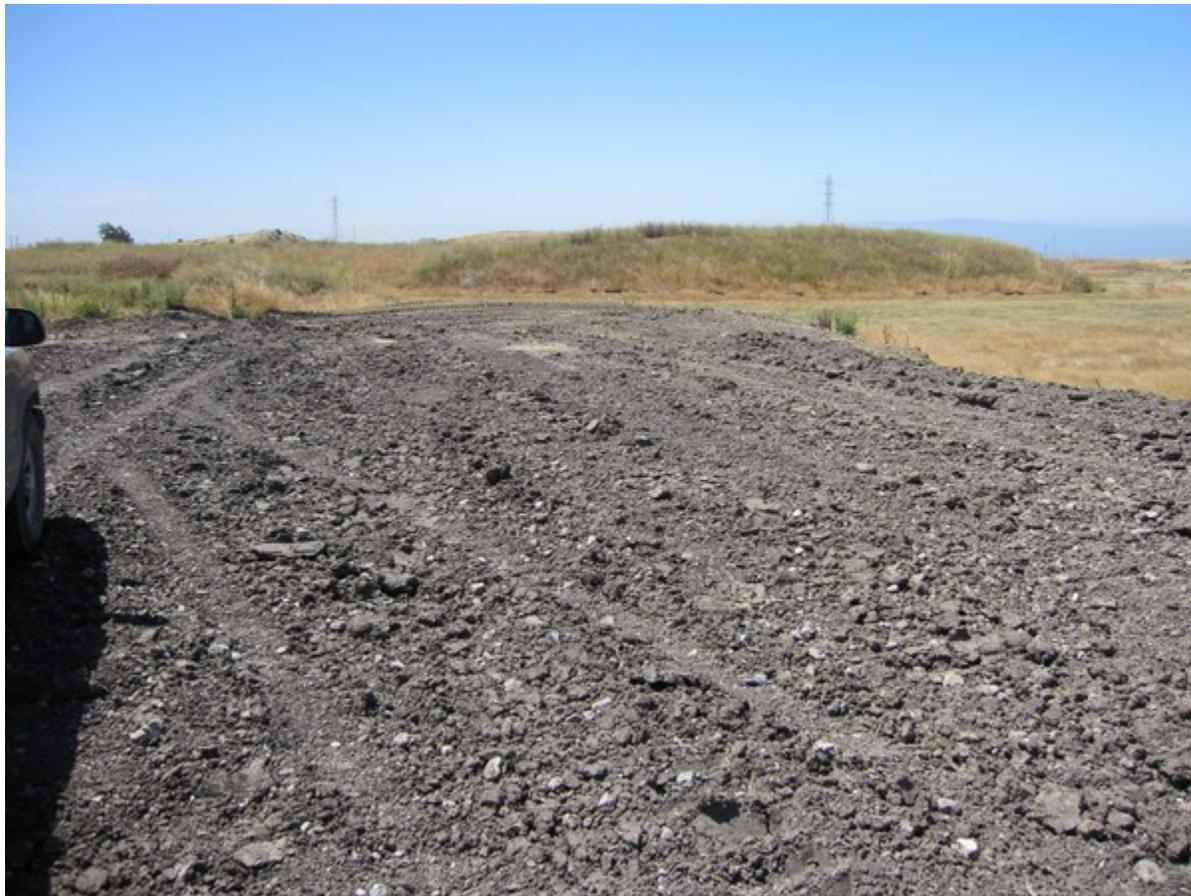
**Photograph 6:** Imported soil piles.

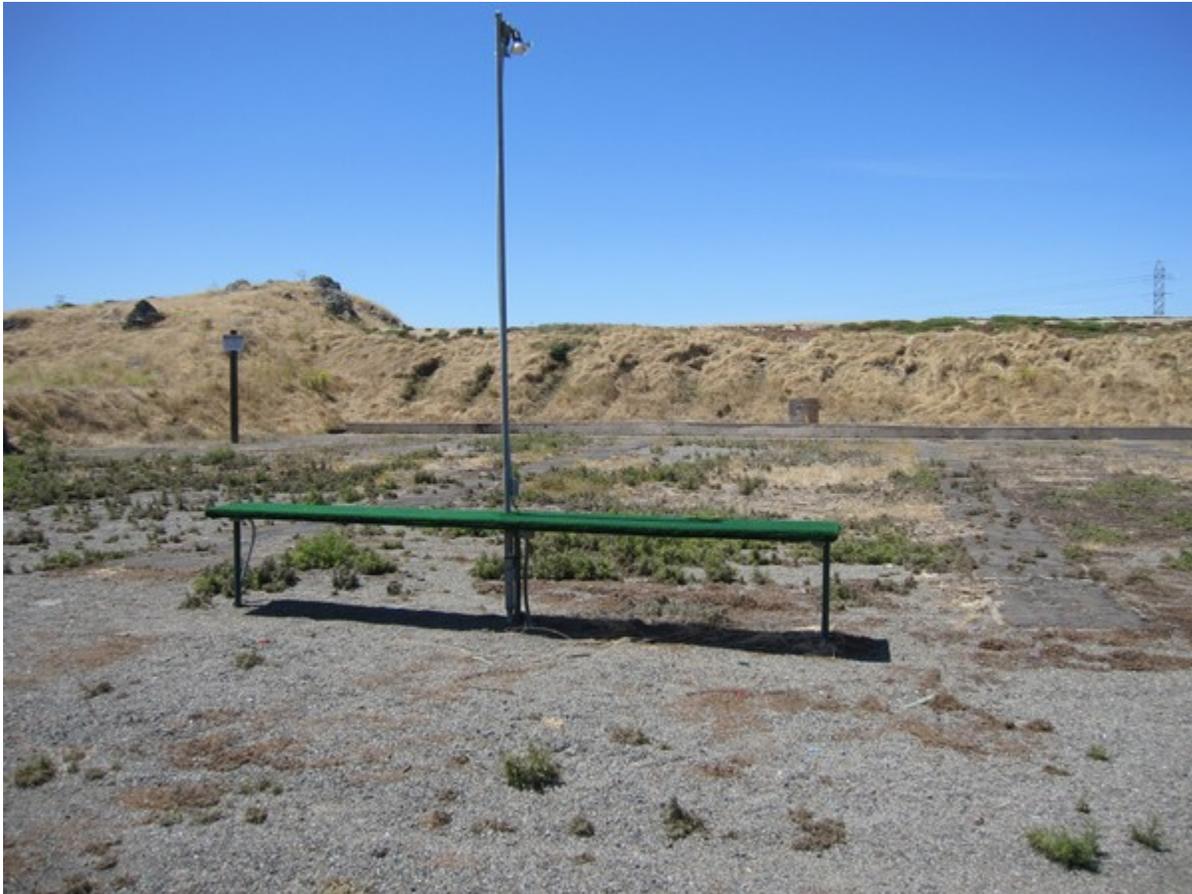
**Photograph 7:** Pistol Range. Serpentine outcrop hill shown at top.

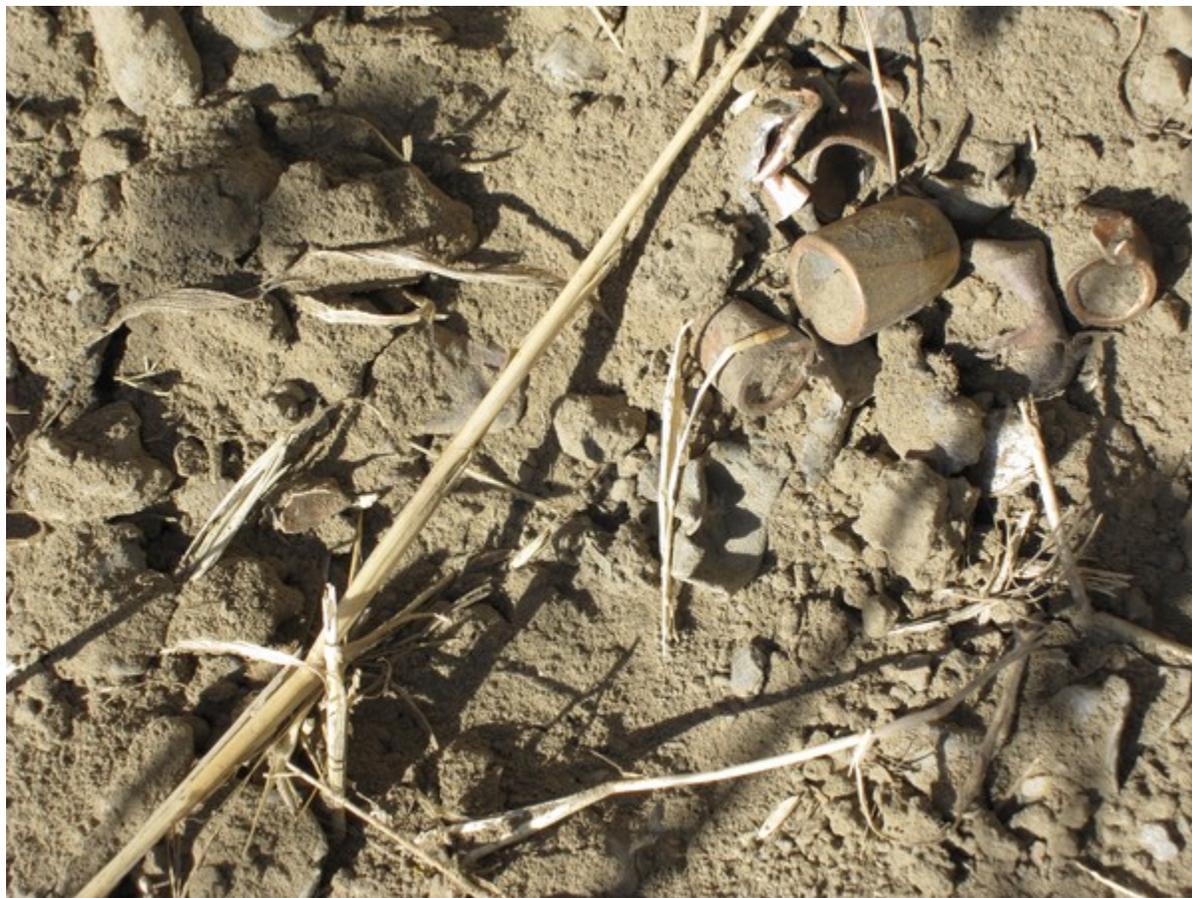
**Photograph 8:** Lead and copper bullet casings in soil at pistol range.

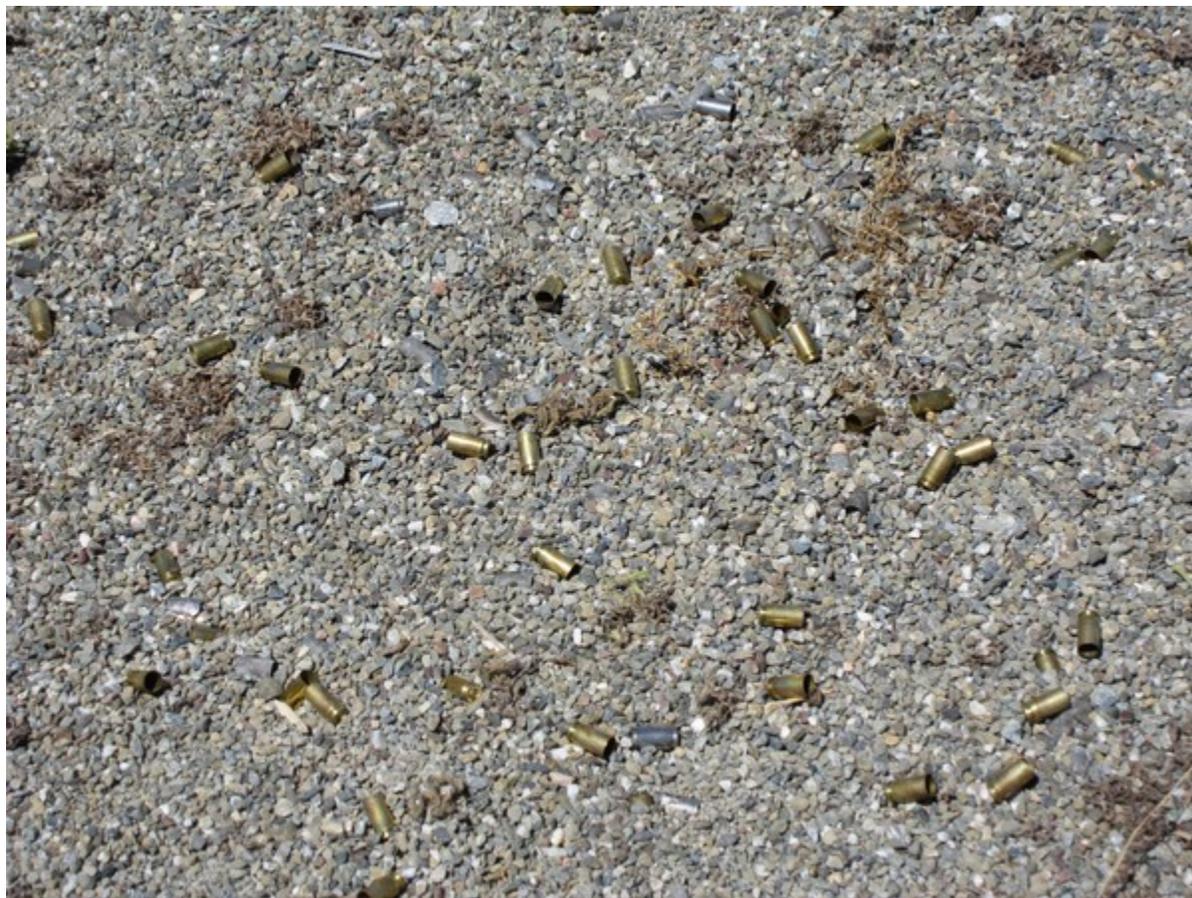
**Photograph 9:** Copper bullet casings on gravel within pistol range area.

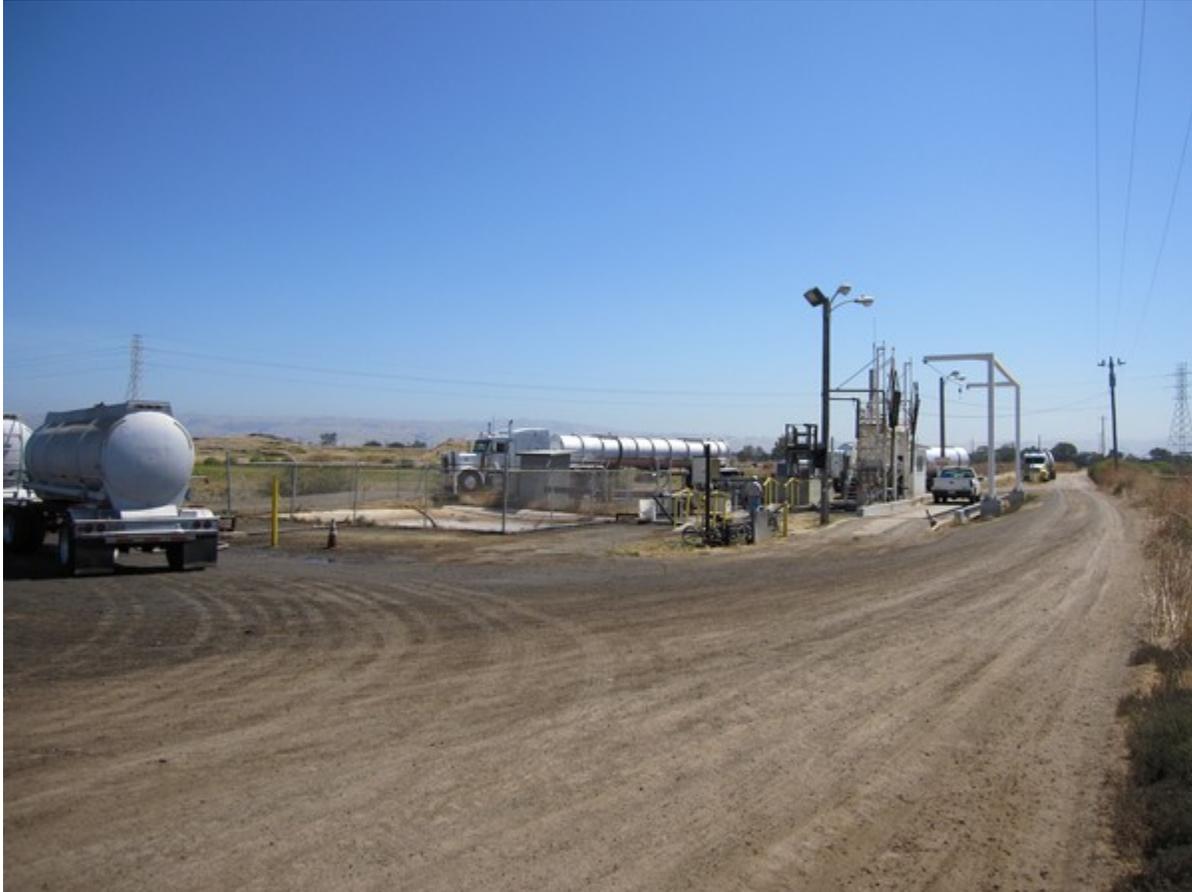
**Photograph 12:** Bittern truck loading facility.

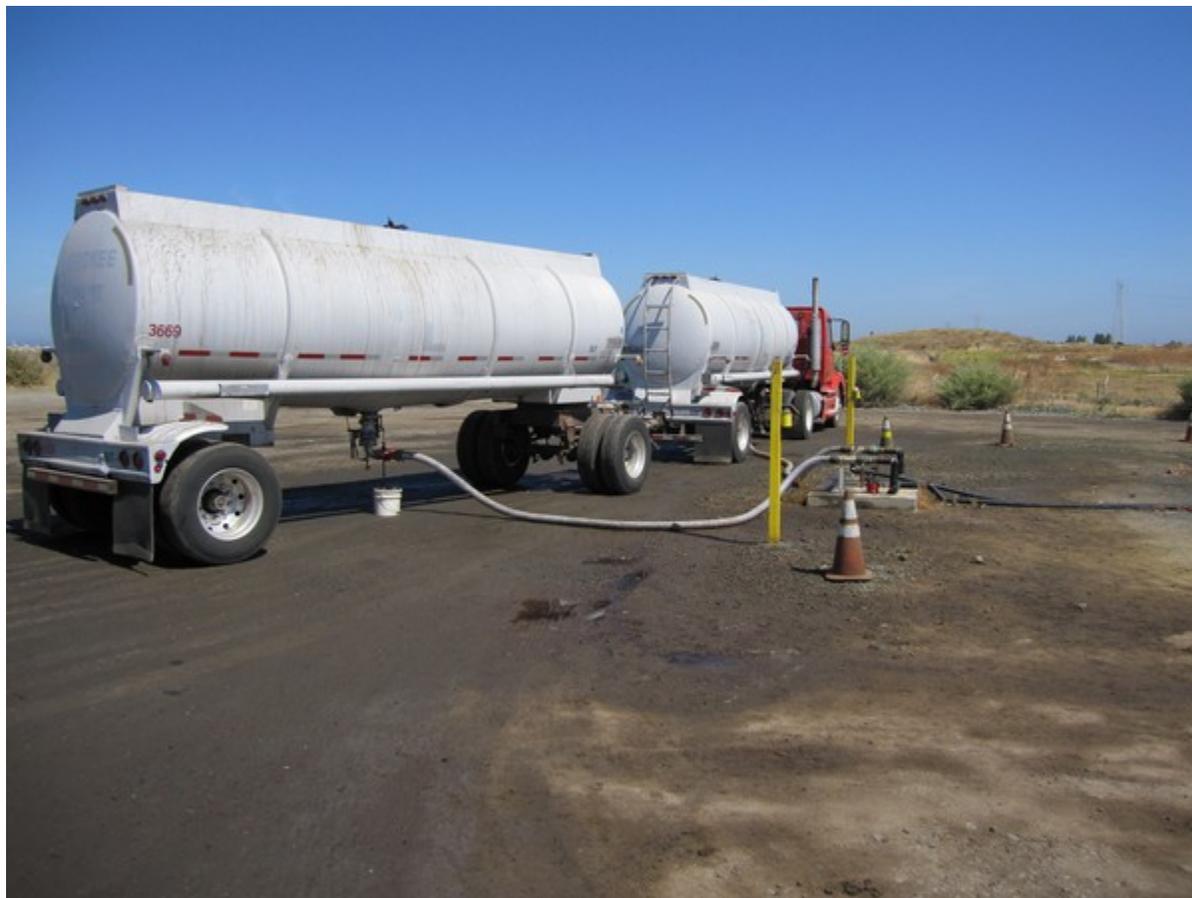
**Photograph 1:** Truck filling location at bittern loading facility. Spilled bittern and stained gravel are apparent.

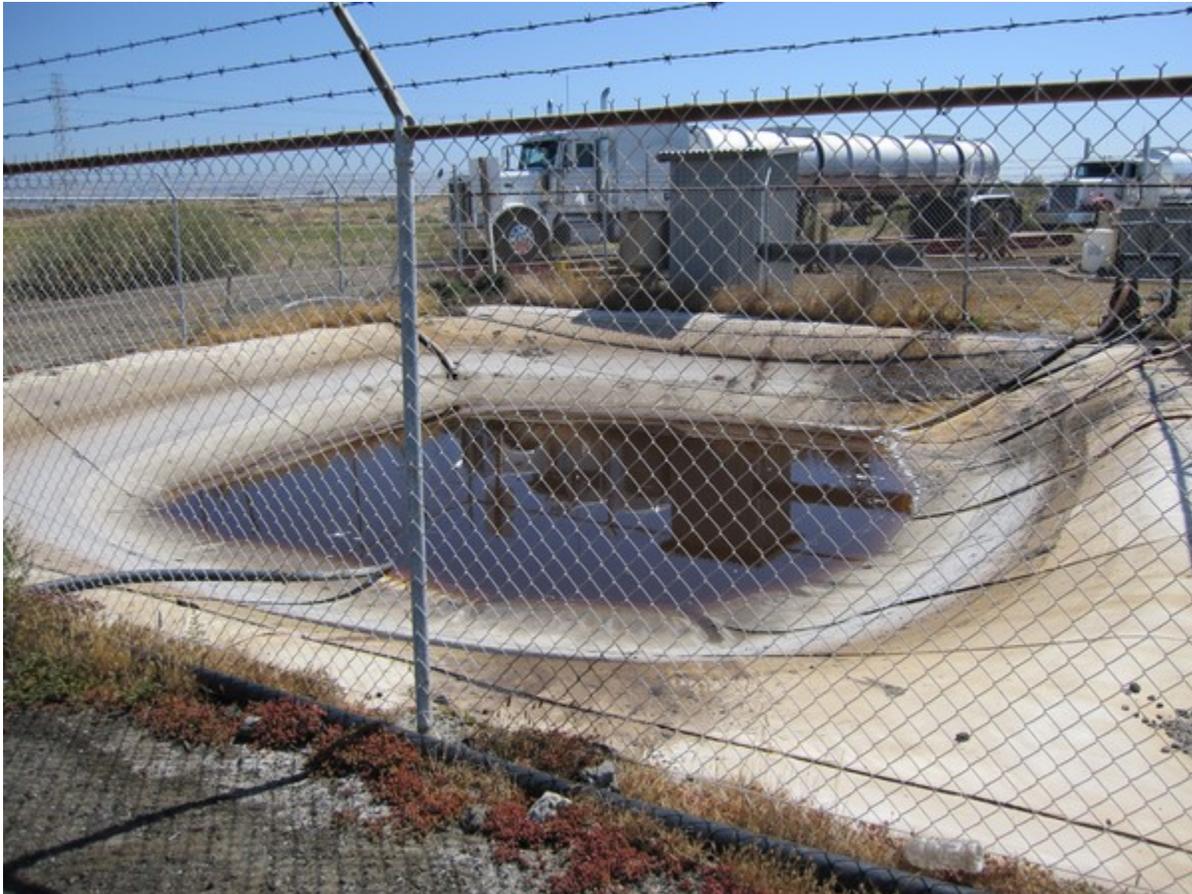
**Photograph 1:** Lined bittern overflow pond.

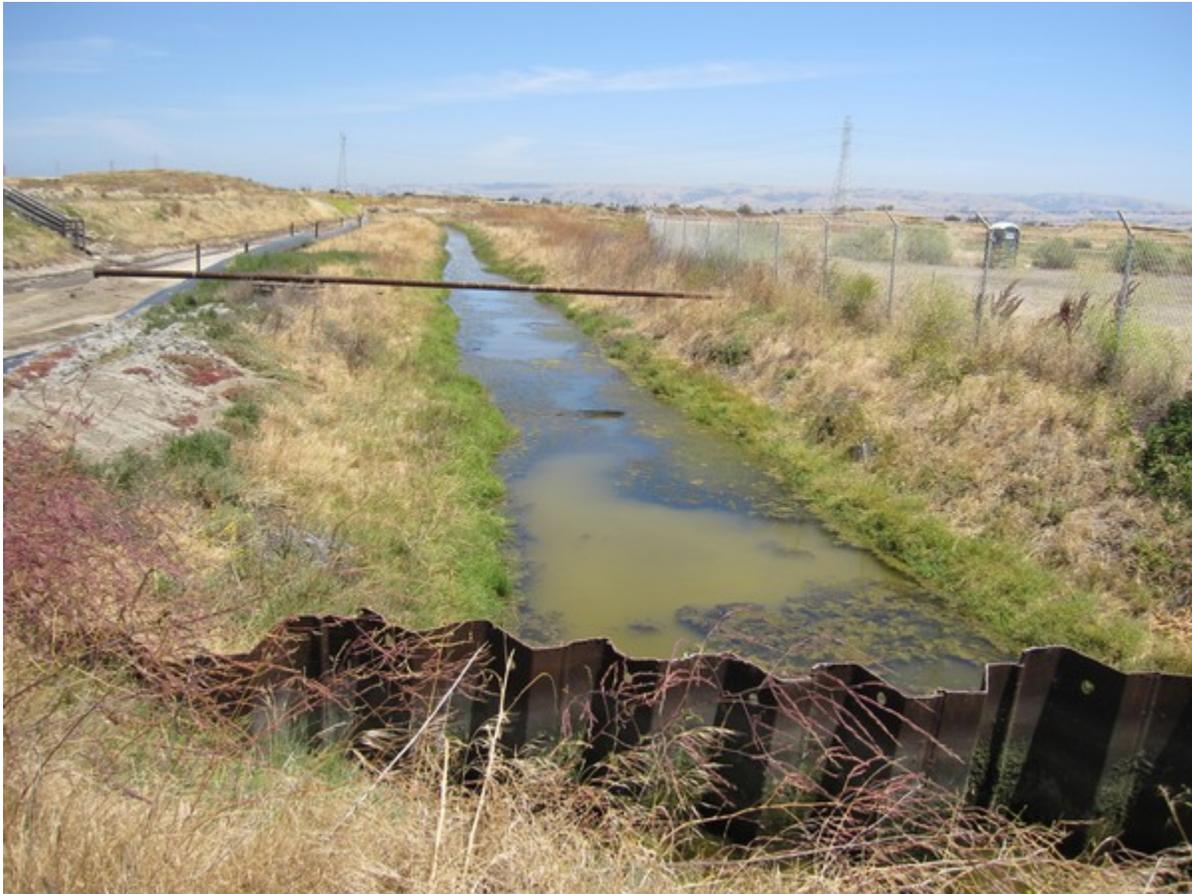
**Photograph 1:** Southern portion of E-1 drainage ditch at southwest corner of the site. The fenced bittern truck loading area is present to the right.

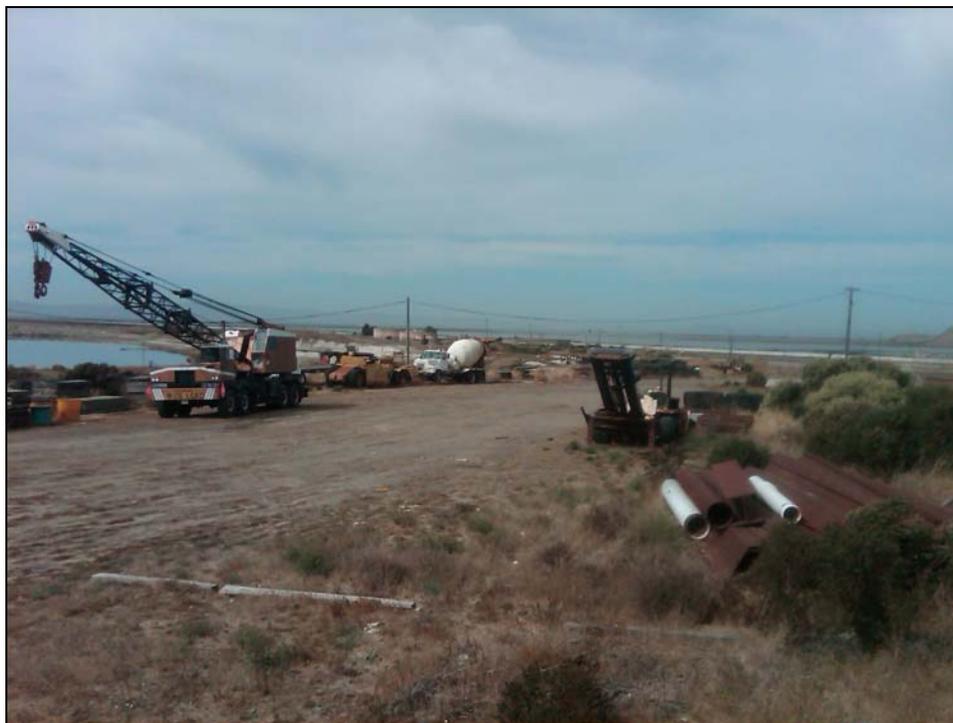
Photograph 2. Northwest-facing photograph showing some of the R.J Gordon Construction equipment stored on the northwestern portion of the subject site.

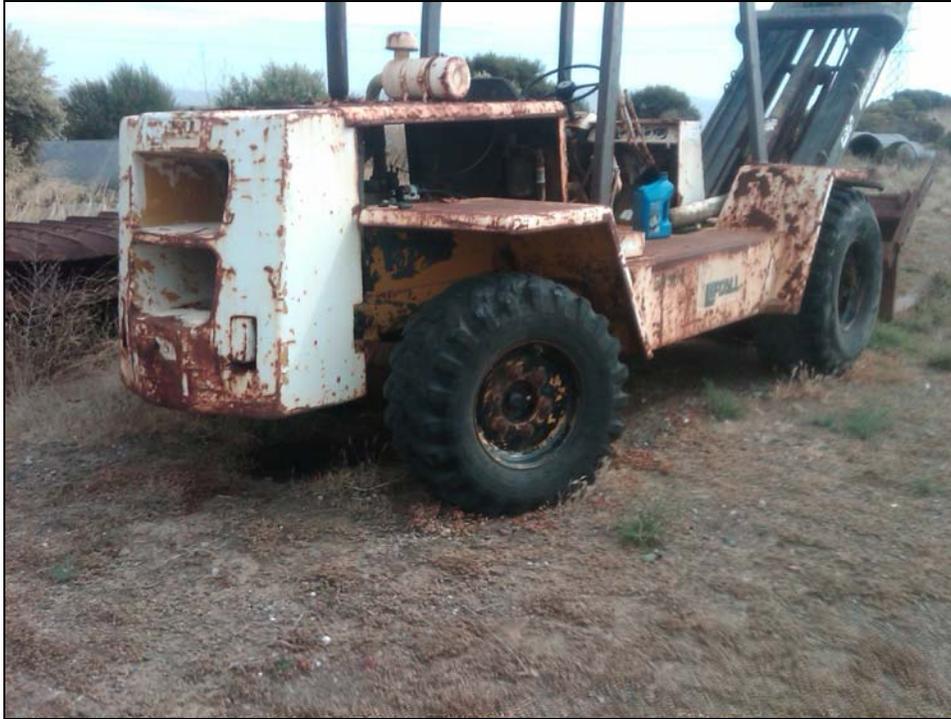
This Phase I ESA has revealed evidence of a *de minimis* condition related to stained soil observed on the northwestern portion of the subject site in an area used by R.J. Gordon Construction to store construction equipment and materials. The stained soil appears to be the result of leaking motor oil or

hydraulic fluid from construction equipment. Due to the heavy nature of motor oil and hydraulic fluid, the impact to the soil caused by this release is likely surficial and is considered a *de minimis* condition.

Photograph 3. Photograph showing an area of stained soil (left-center of the photograph) caused by leaking engine fluid from a fork lift on the northwestern portion of the subject site.

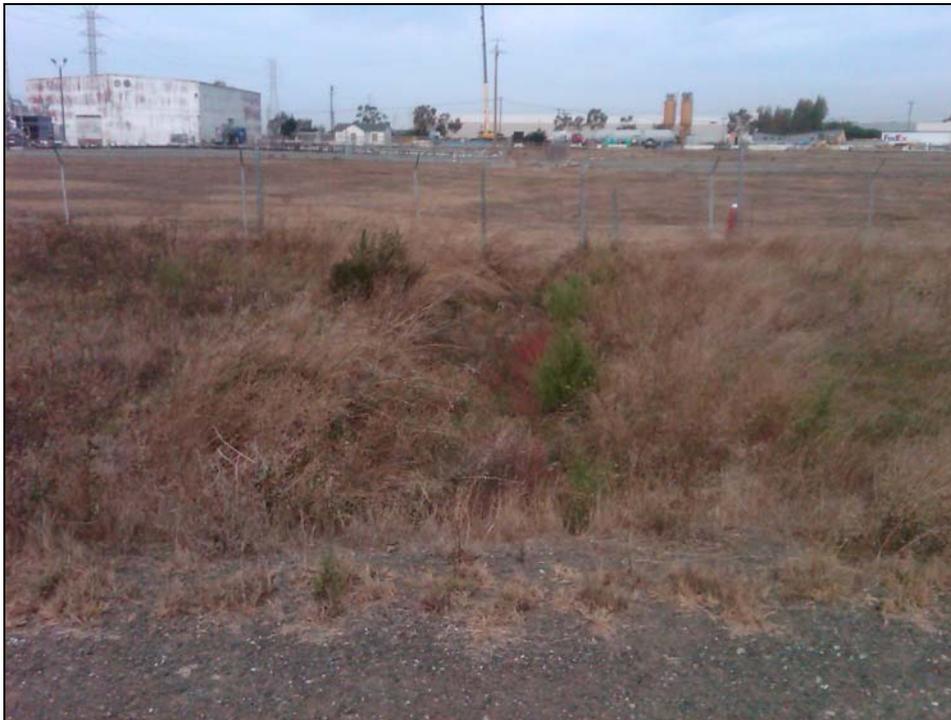
Photograph 4. North-northwest-facing photograph showing the northern portion of the E-1 Ditch as it appears adjacent to the south of the former FMC property and north of the access road.

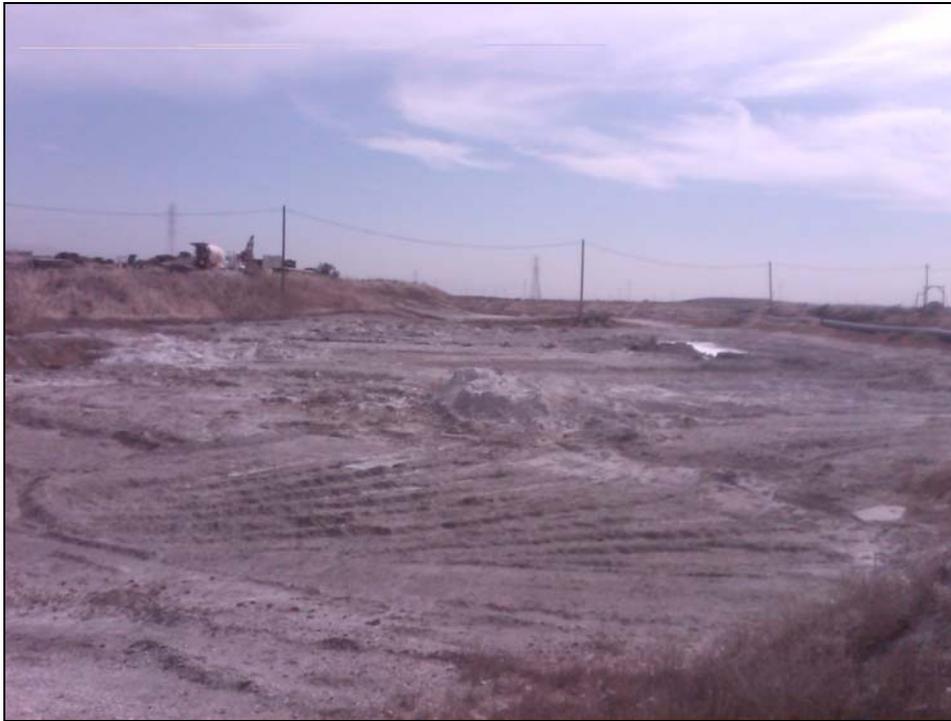
Photograph 5. Southeast-facing photograph showing a former magnesium sulfate settling pond located on the northwestern corner of the subject site.

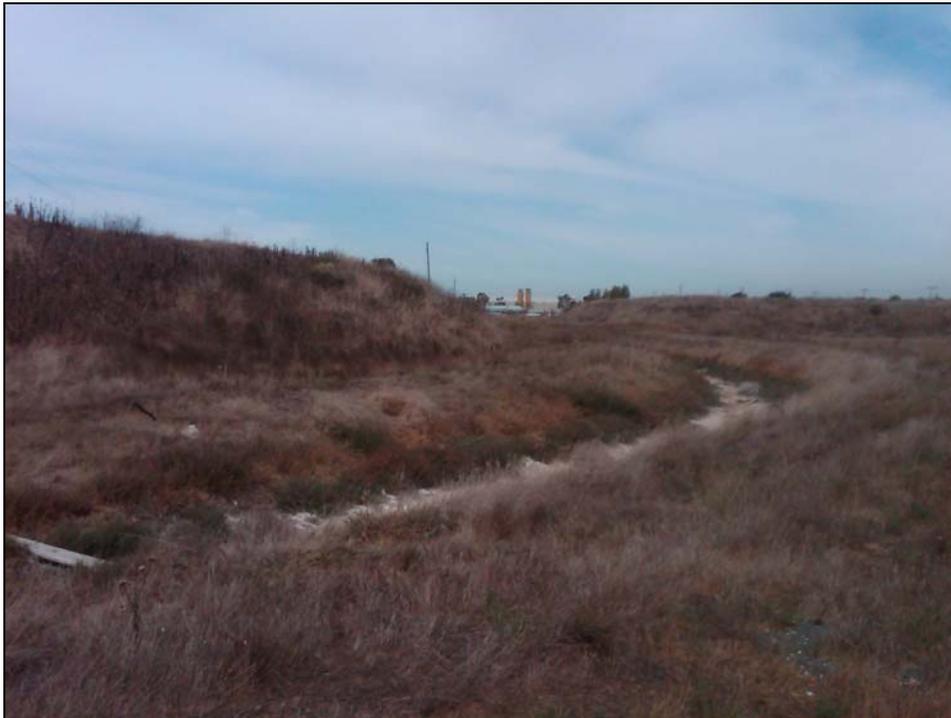
Photograph 6. North-facing photograph showing the E-1 Ditch from the central portion of the subject site.

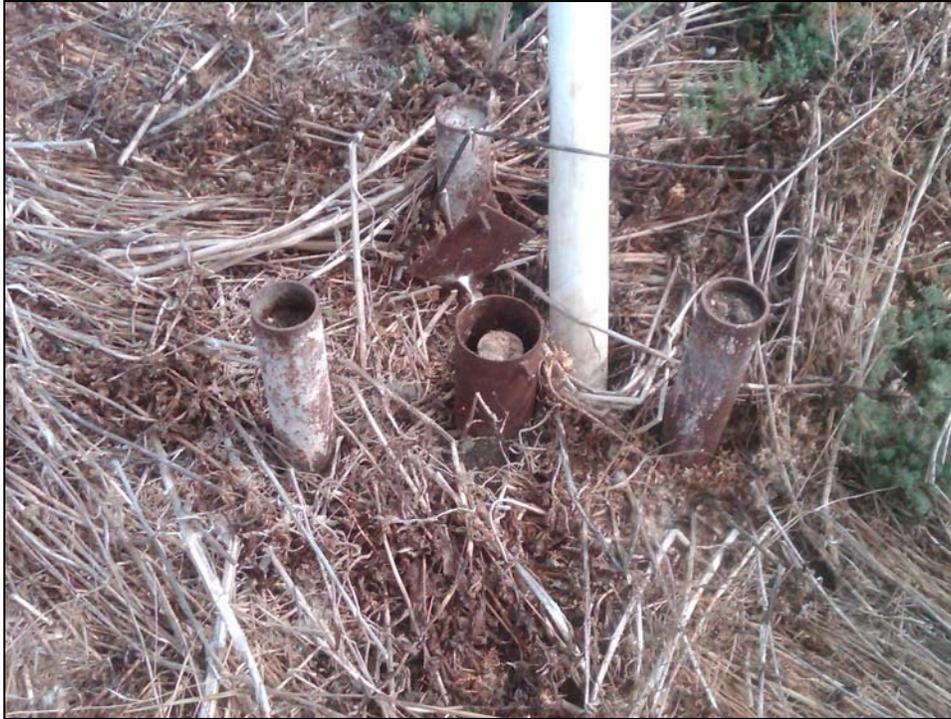
Photograph 7. Photograph showing one of three 2-inch diameter groundwater monitoring wells located on the northeastern portion of the subject site.

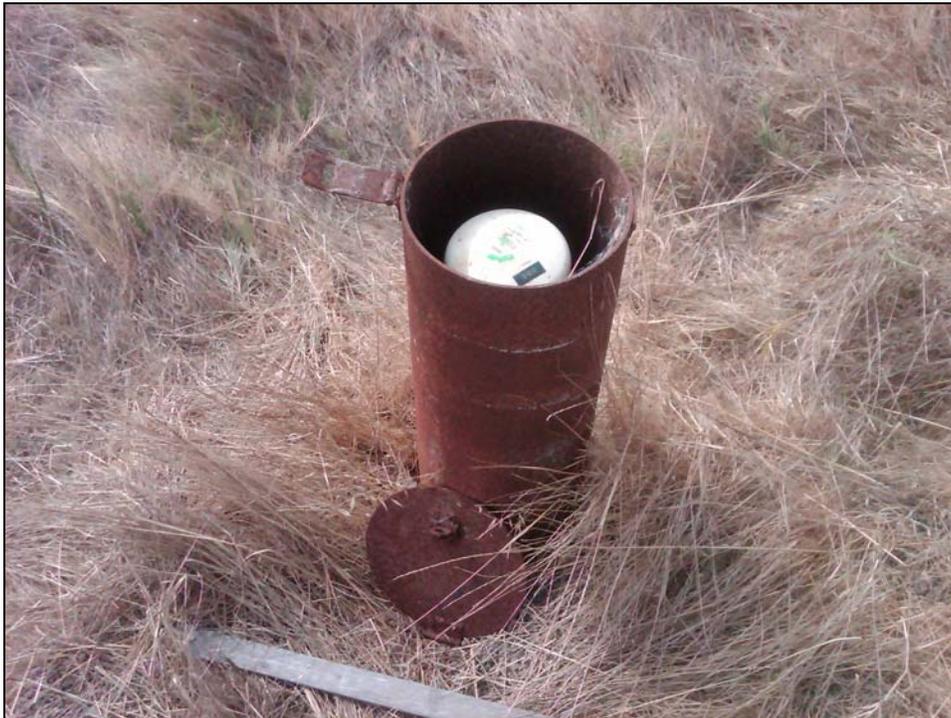
Photograph 8. Photograph showing the 4-inch diameter groundwater monitoring well located on the east side of the E-1 Ditch on the northeastern portion of the subject site.

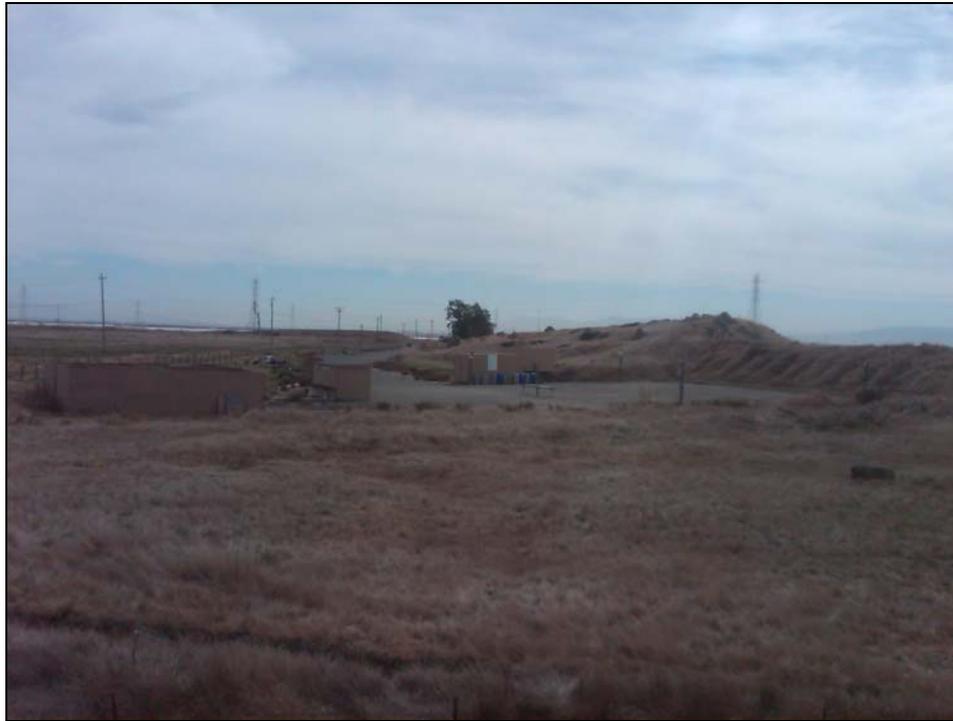
Photograph 9. Southeast-facing photograph showing the Newark Police Department Pistol Range on the southeastern portion of the subject site.

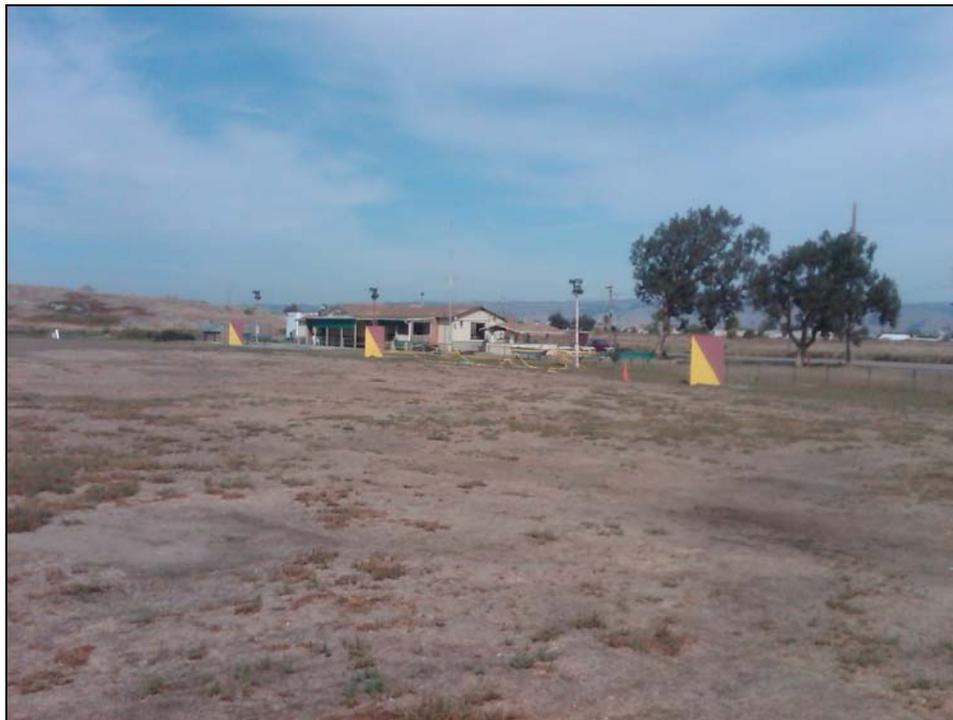
Photograph 10. Northeast-facing photograph showing the K-9 training area and clubhouse at the Witmer-Tyson Police Dog Training School on the southeastern corner of the subject site.
