**Type of Services** Screening Level Hazardous Materials Review

**Location** Areas 3 and 4  
Newark, California

**Client** David J. Powers & Associates

**Date** August 21, 2007

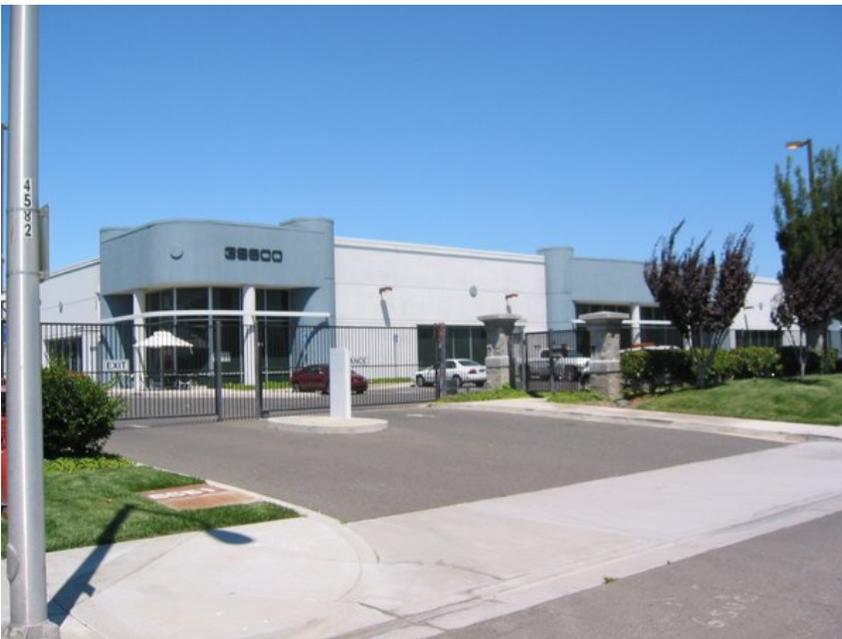
Photograph 8. Typical commercial building on CET parcel.

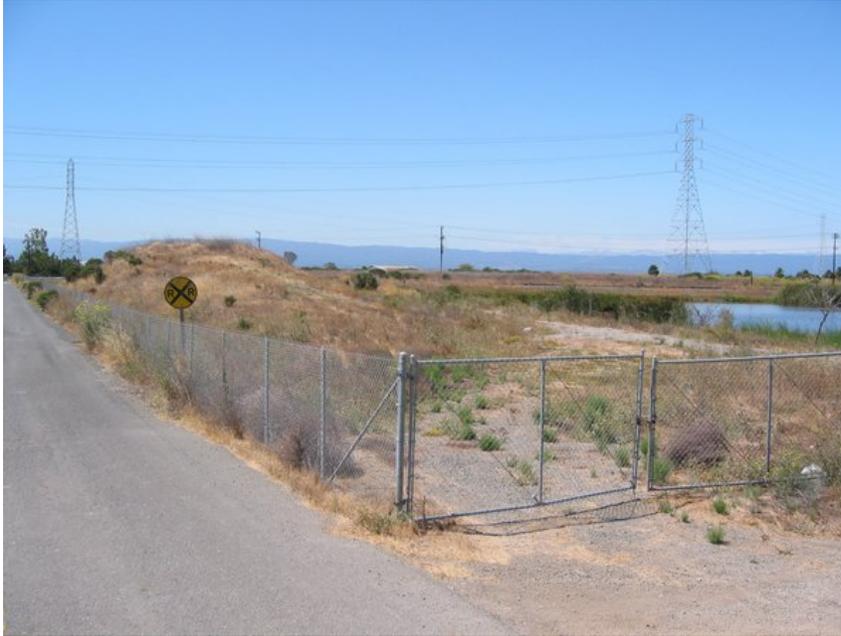
Photograph 9. Soil mound and pond on CET parcel (southern corner).

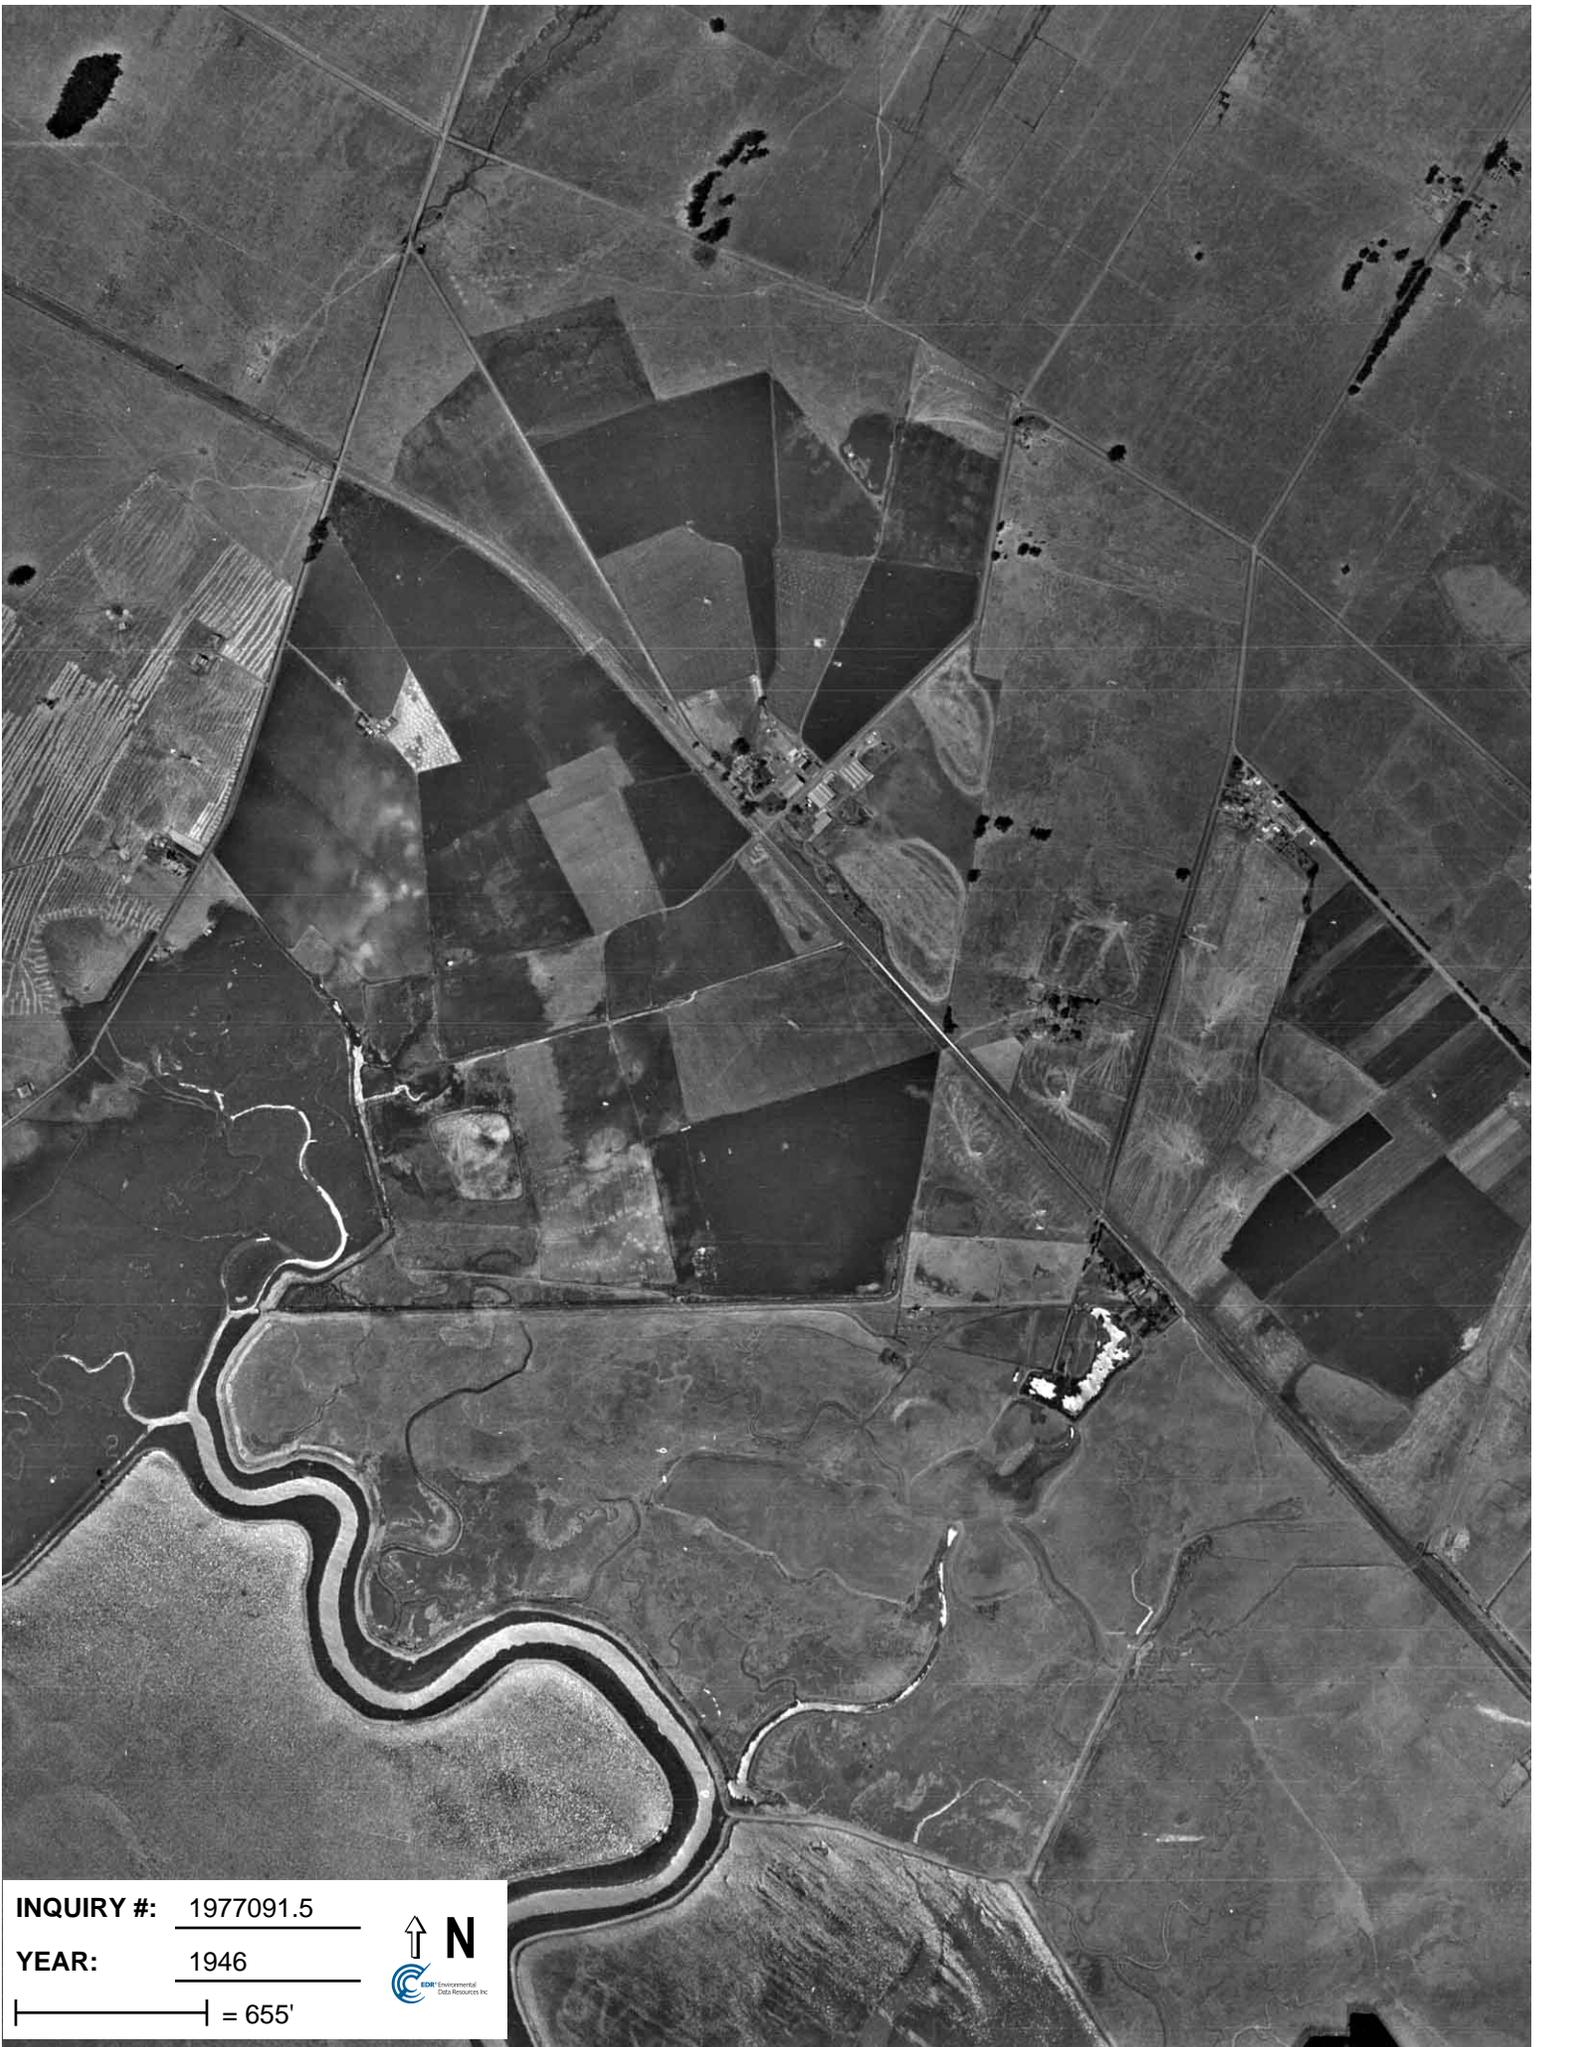
**YEAR:** 1946

**1946:** The 1946 aerial photograph shows site conditions to be generally similar to those shown on the 1939 photograph. One notable exception is that a pattern of lightly shaded objects, possibly mounds of hay or soil, are apparent on property that consists of the eastern corner of the current auto dismantling yard and the southeastern corner of the unnamed, triangular shaped parcel located to the northeast of the current auto dismantling yard.

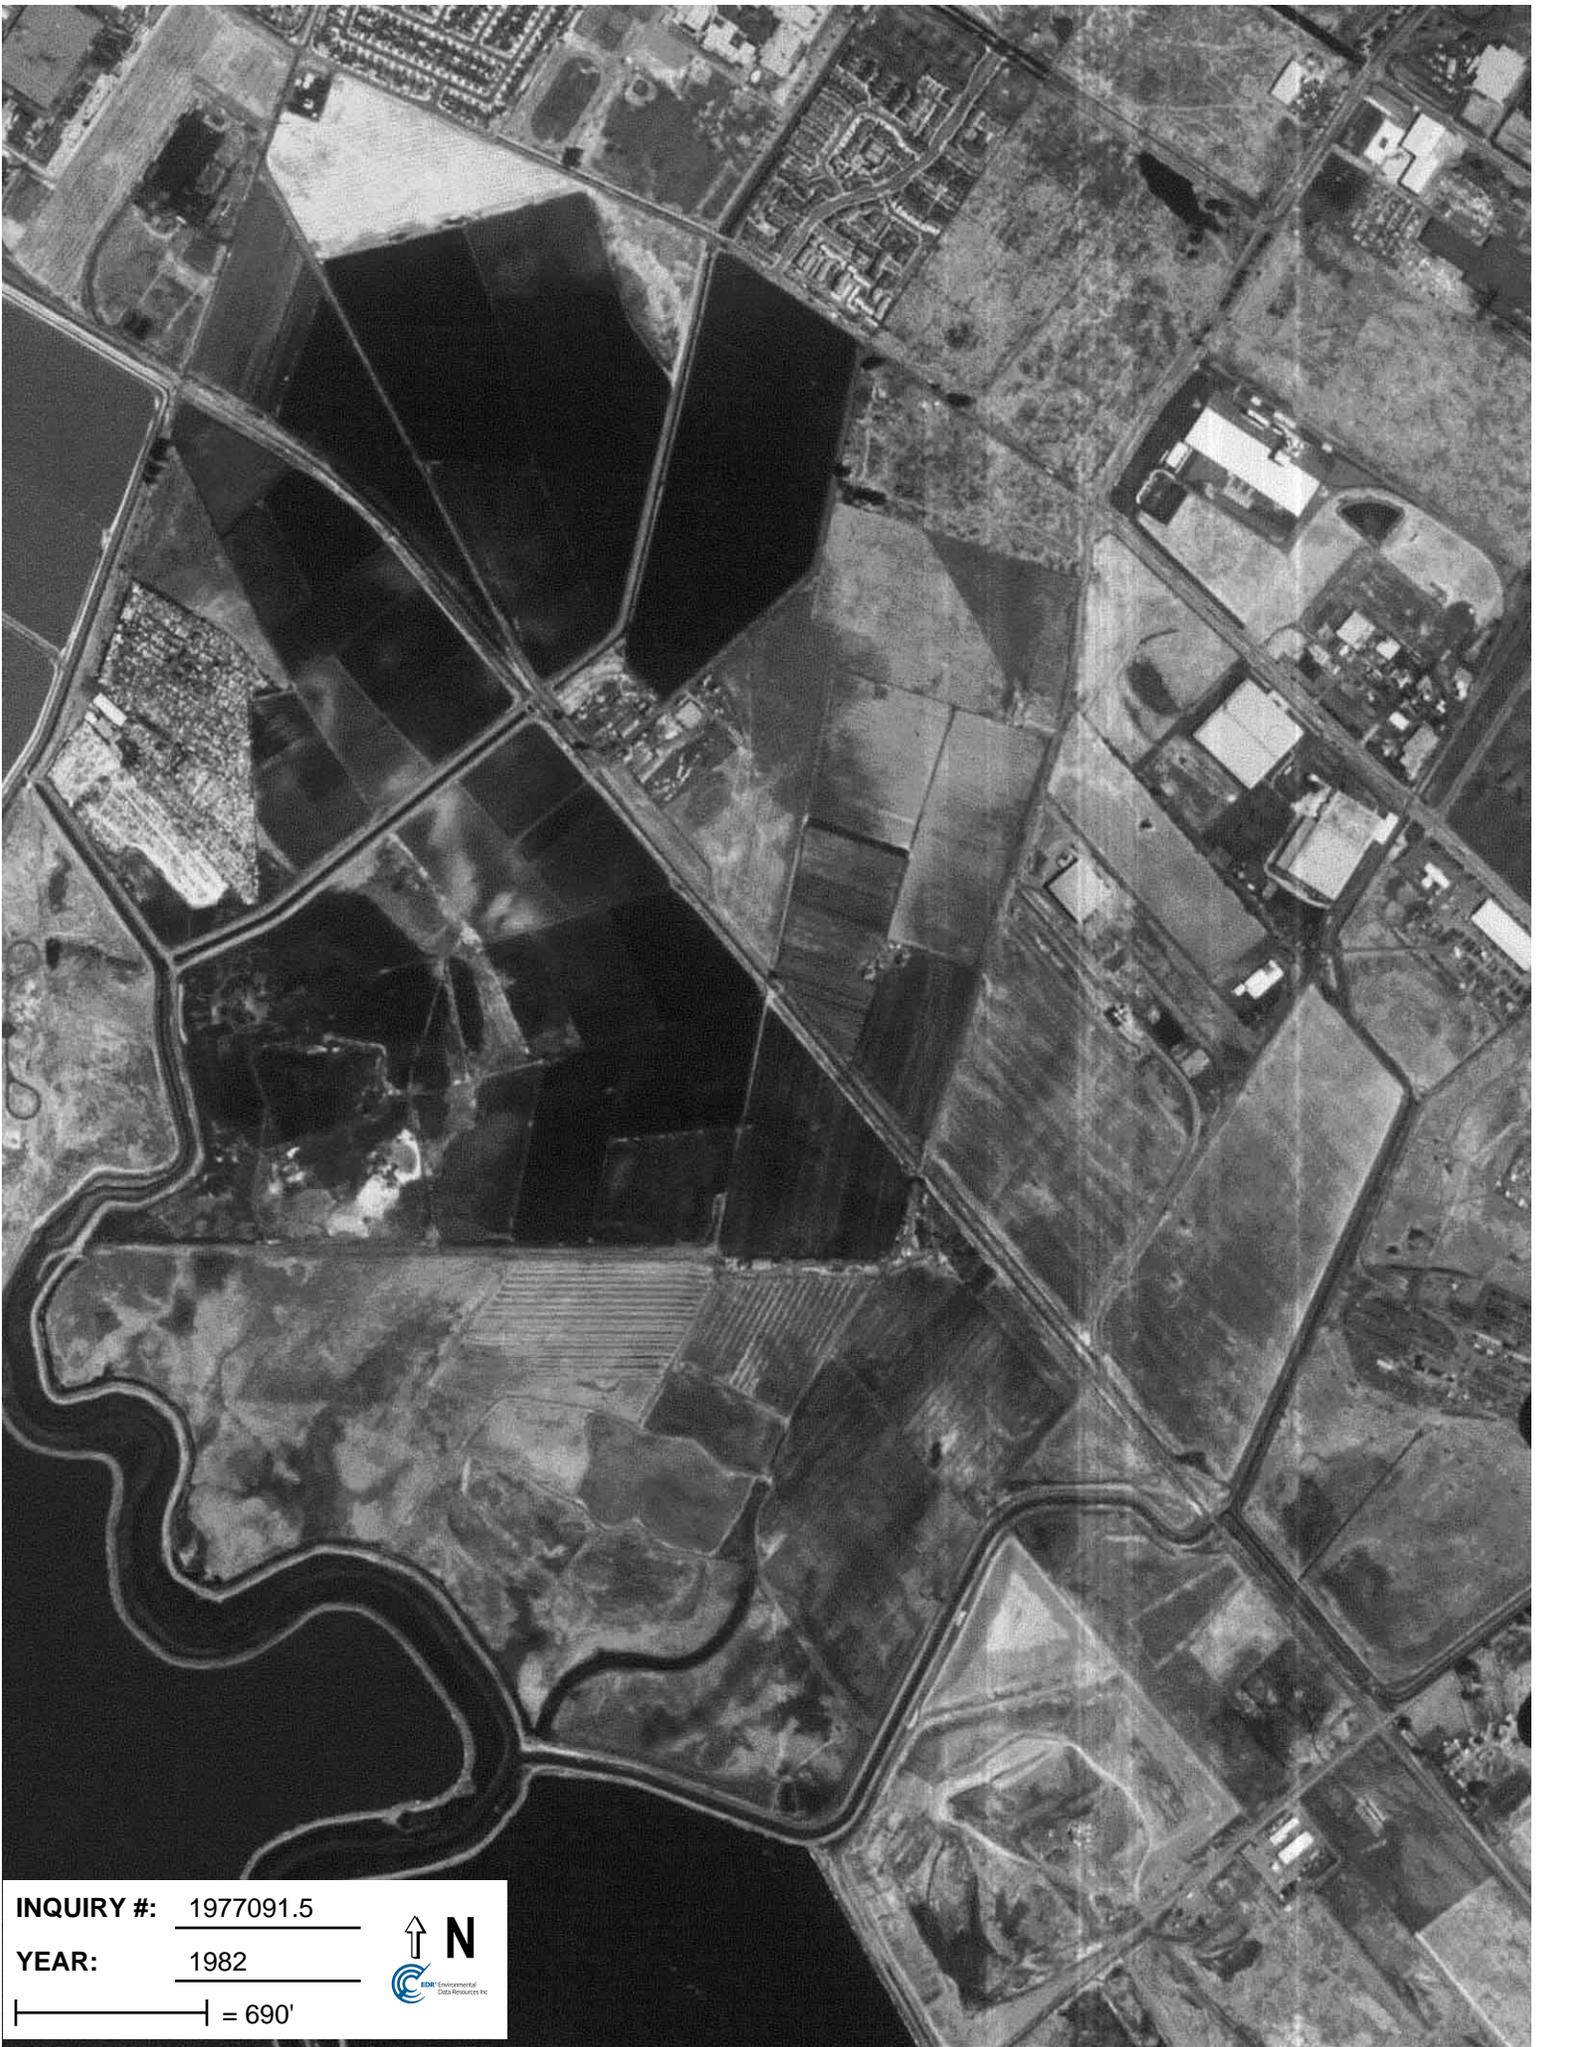
**YEAR:** 1982

**1982:** Similar site conditions are shown on the 1982 aerial photograph, except that auto dismantling facilities are shown to be present on the western portion of the site along Mowry Avenue. Stored vehicles are shown to cover the parcel that is currently used for auto dismantling (Pick-N-Pull and Ace Auto Wrecking sites) as well as the 10-acre Mowry Avenue site. Additionally, what appears to be the current fire station building is shown to be present on the southern corner of the Mowry Avenue and Cherry Street intersection.
